Designation of Critical Habitat Lake Redstone, Sauk County, Wisconsin

**Donna Sefton & Susan Graham
South Central Region
Wisconsin Department of Natural Resources
Fitchburg, Wisconsin
Final Report
January 5, 2009**

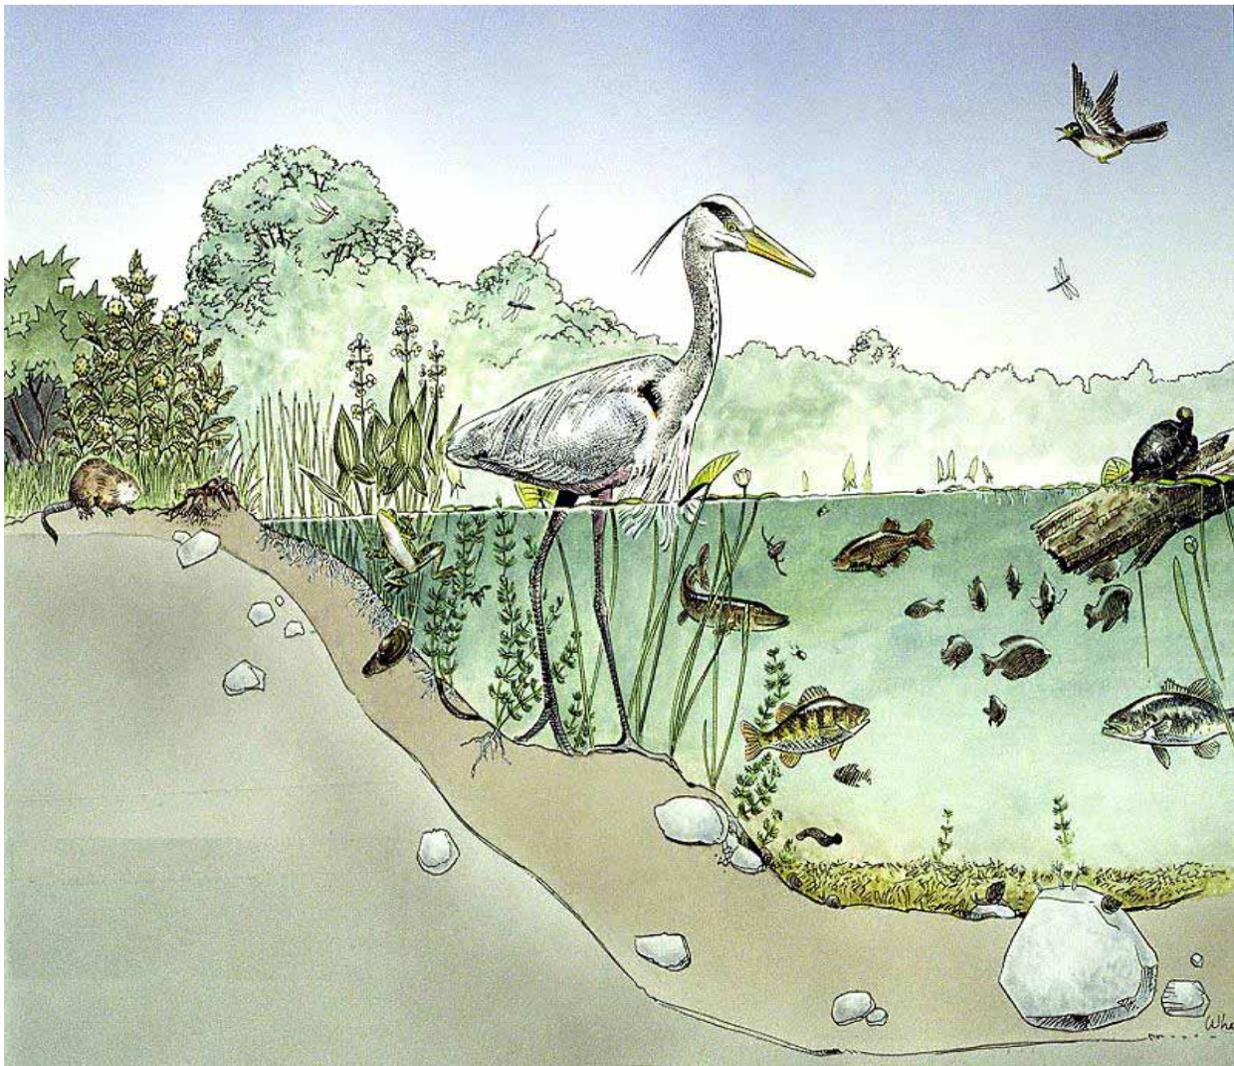
Figure 1. Location of important near-shore and shallow water habitat about which Critical Habitat designations are most concerned.

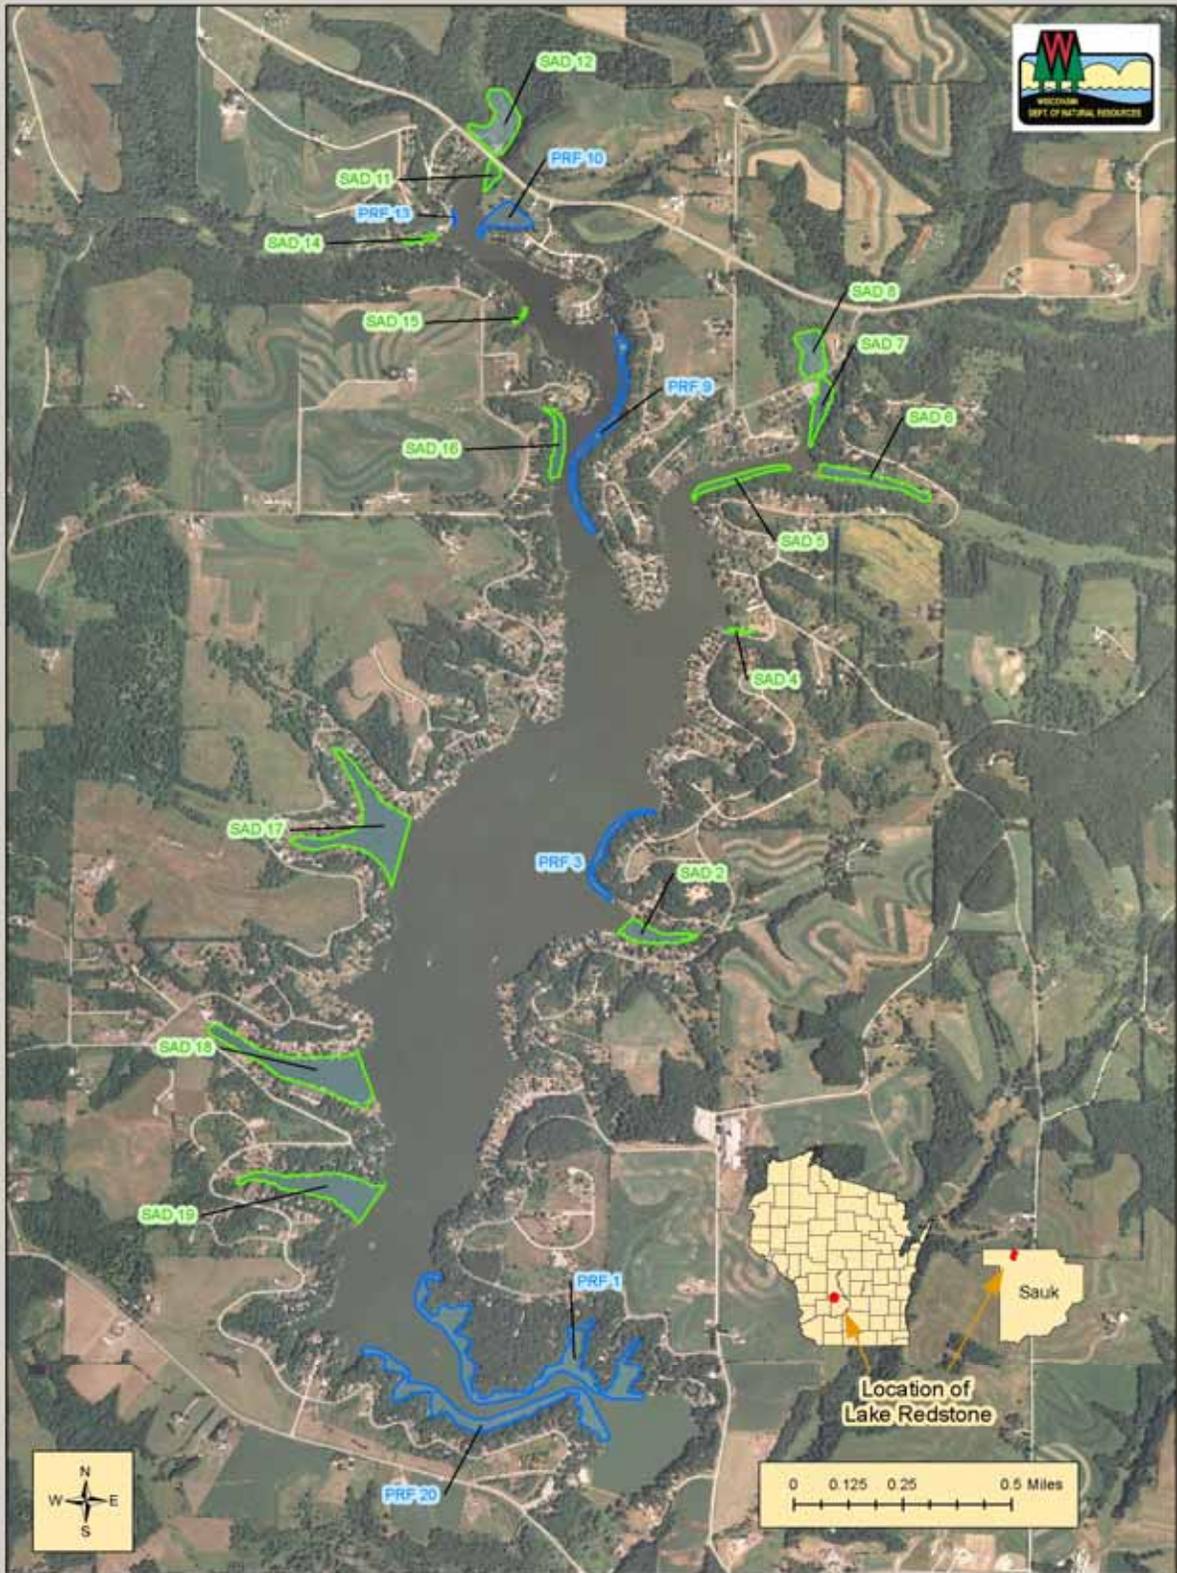
Figure 2. Location of Lake Redstone Critical Habitat: Sensitive Areas (SAD) and Other Public Rights Features (PRF).

There were 20 areas designated as Critical Habitat for Lake Redstone (Figure 2). Fourteen of these were classified as Sensitive Areas for their aquatic vegetation and 6 were classified as Other Public Rights Features for containing reaches of shore that are predominately natural in appearance or that screen man-made or artificial features, and/or fish and wildlife habitat values. All are classified as Public Rights Features.

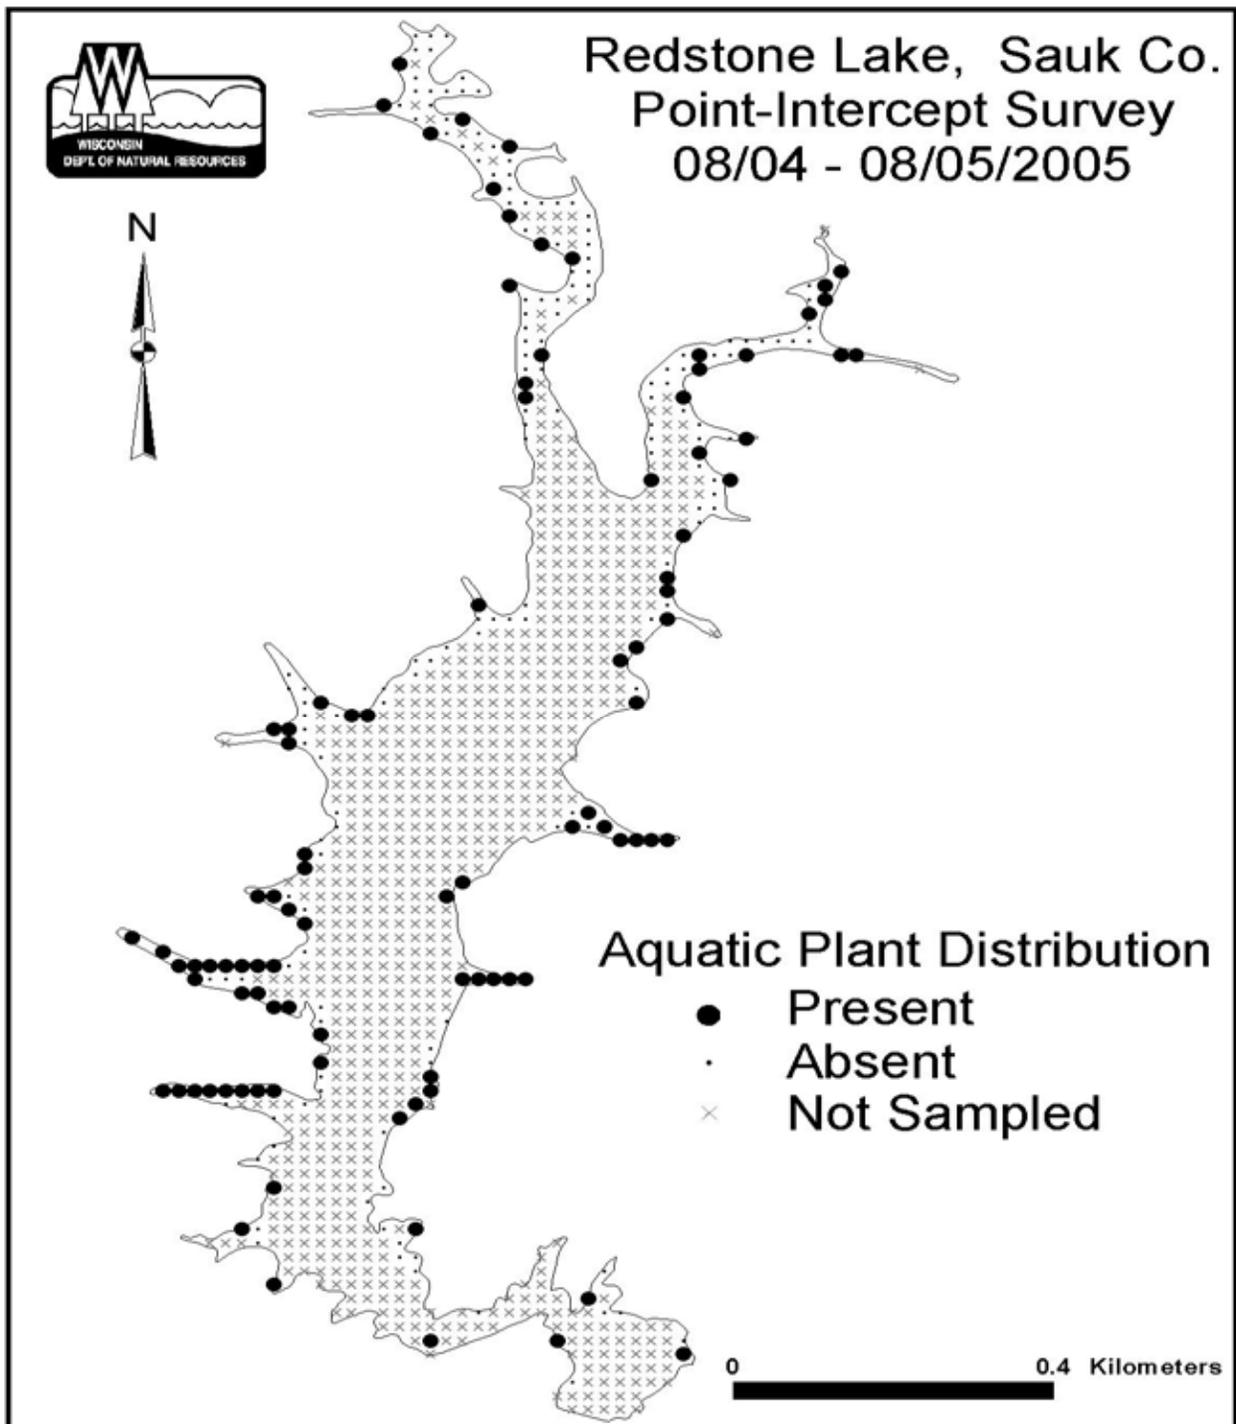
Figure 4 . Lake Redstone aquatic plant distribution, August, 2005. Presence and density of plants was higher earlier in the summer according to Aquatic Plant Management pre-treatment survey notes.

Figure 4 shows the distribution of all aquatic plant species combined, and maps of the distribution of most of the individual species recorded during the August, 2005 survey are found in Appendix B. The water quality and fish and wildlife benefits of these plants are summarized in Table 3.

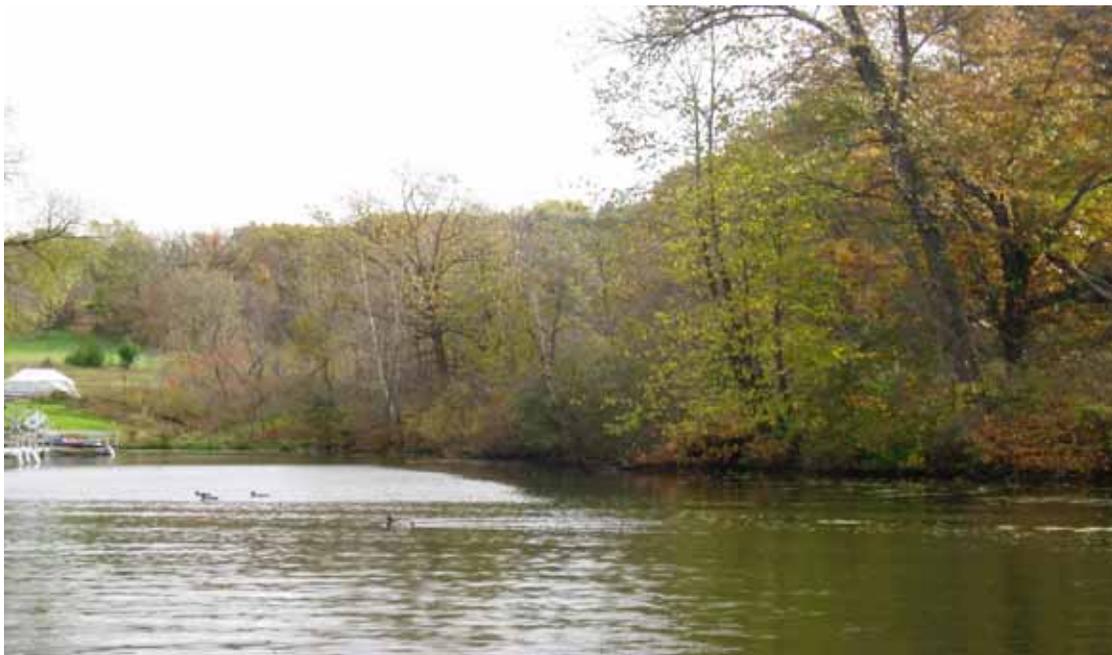
Figure 14. Lake Redstone Critical Habitat 4.

This Critical Habitat is the east inlet on the south edge of the northeast arm near Bob O Link Court (Figure 13). It is adjacent to Tanager Outlots 1 and 2. The shoreline at this Critical Habitat Area is 100% wooded, with trees and shrubs dominant and herbaceous cover abundant. Bracken fern and dogwood, along with willows, sugar maples and birch were noted on the slopes. Some snags were also present. Turtles and ducks were observed. Large woody cover from some fallen trees is present in the shallow water. This woody cover provides important habitat for fish and wildlife areas. A photo of the area is shown in Figure 14.

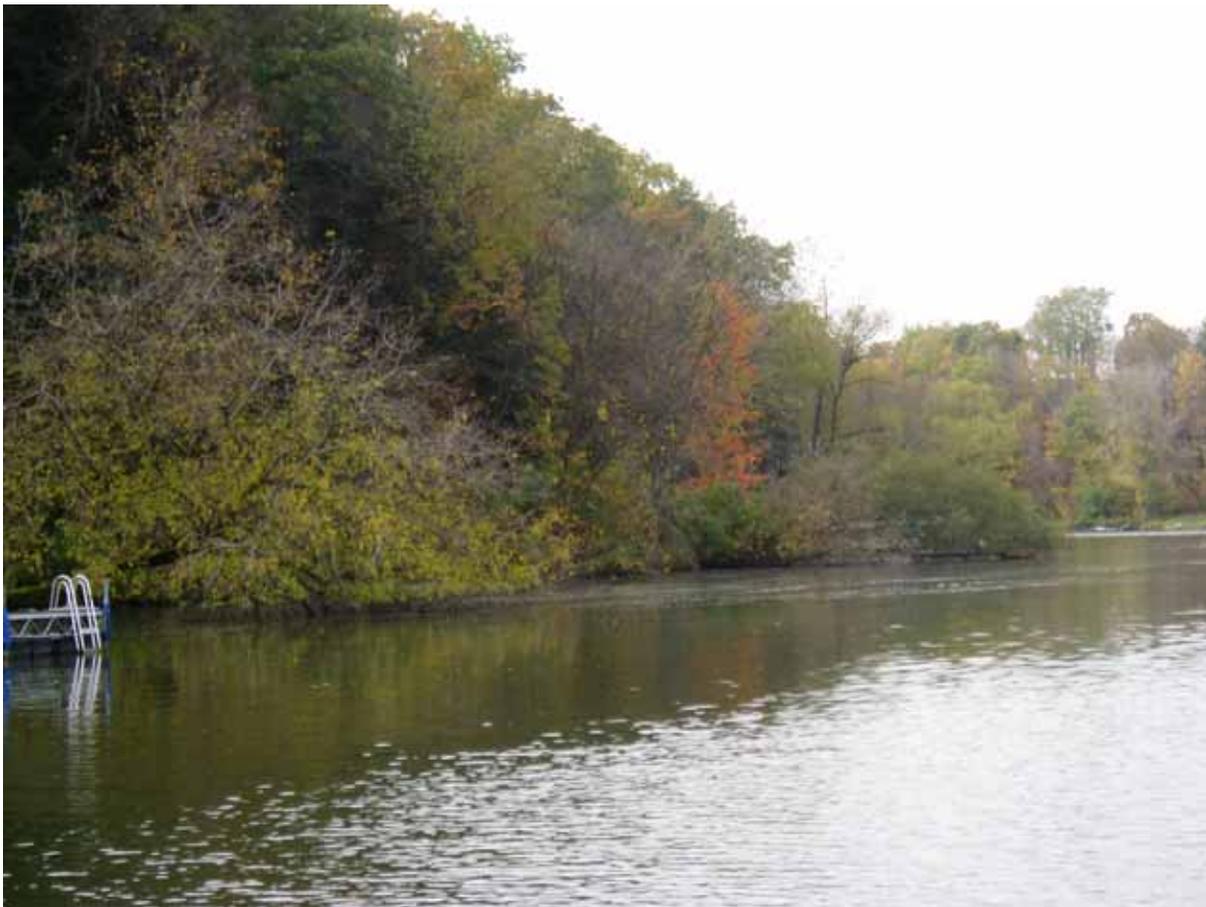
Figure 16. Lake Redstone Critical Habitat 5.

This Critical Habitat is located along the northern shore of the big point in the southeast portion of the Northeast Arm along East Redstone Drive (Figure 15). It is adjacent to the Public Access lot between Tanager Lot 28 and Swallow Outlot 1, and includes Swallow Outlot 1 and Lots 15-22. The shoreline at this Critical Habitat is composed primarily of trees, with very minimal development apparent. Trees overhanging the water provide a unique feature. Hemlocks, sugar maple and birch are found on top of the cliffs. A photo of the area is found in Figure 16.

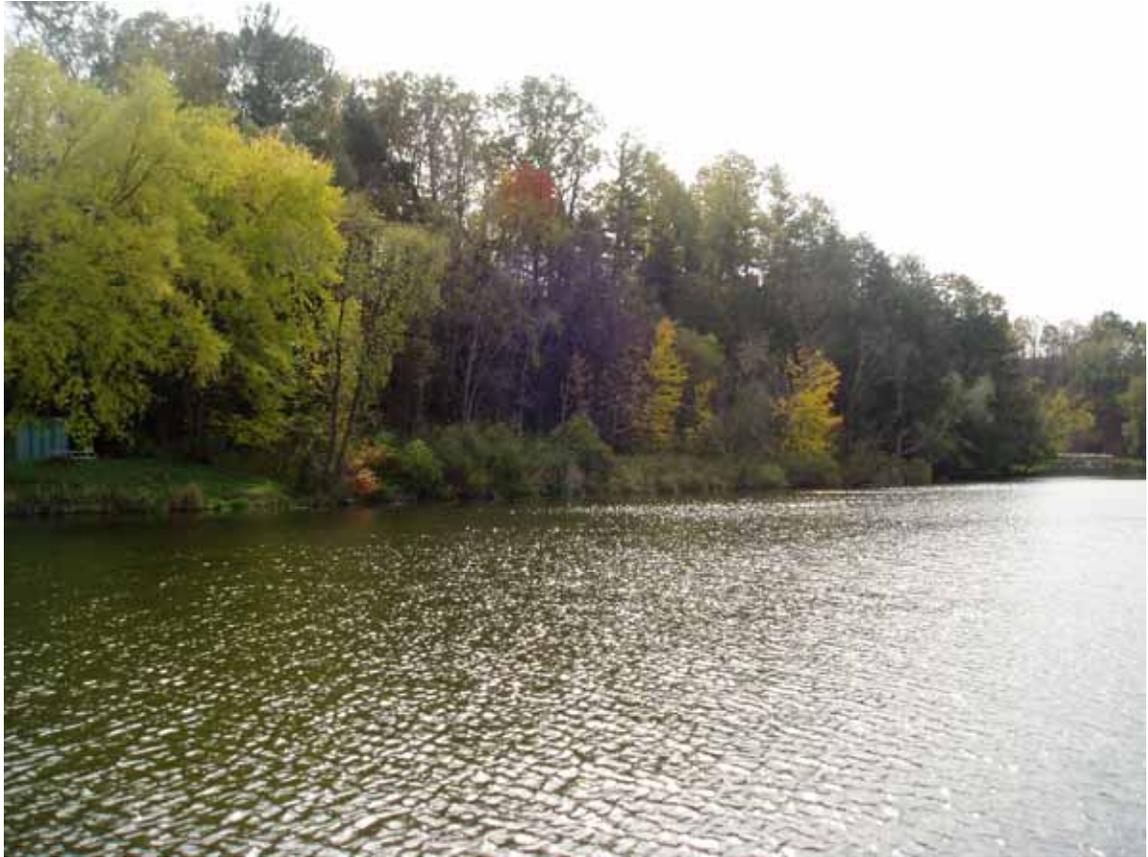
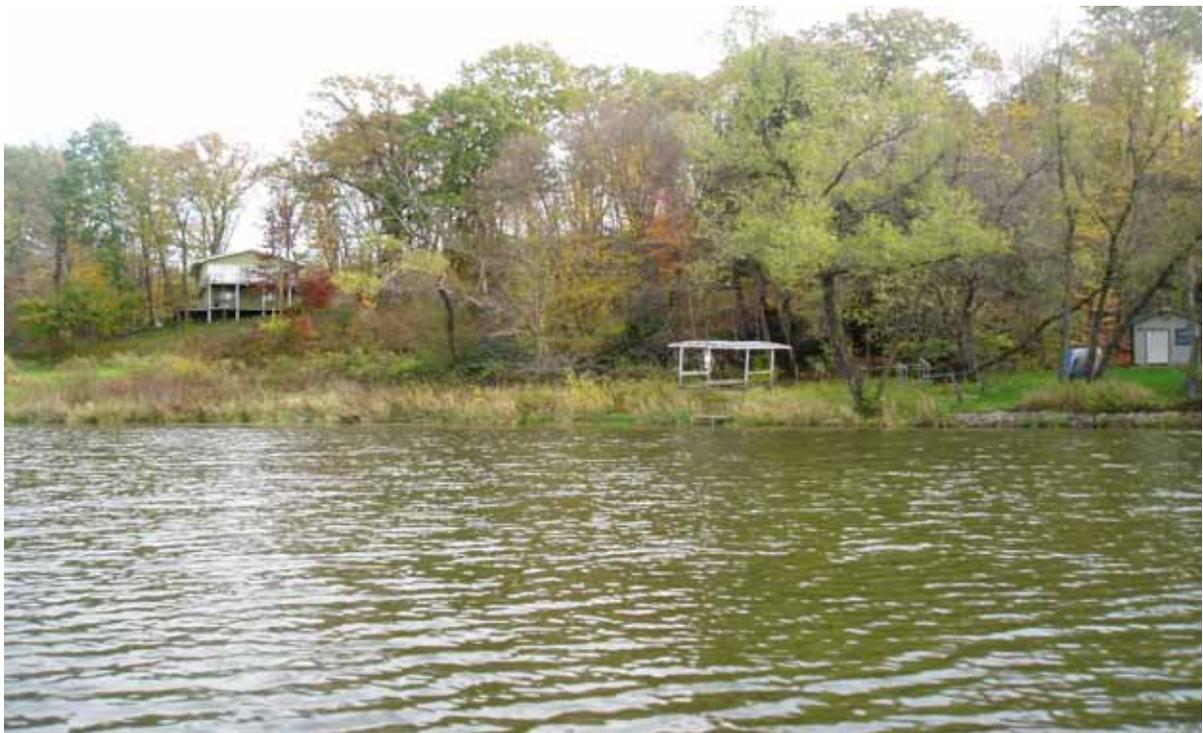
Figures 22 and 23. Lake Redstone Critical Habitat 7.

This site supports important near-shore terrestrial habitat, shoreline habitat and shallow water habitat. Large woody cover from some fallen trees is present in the shallow water. This woody cover provides important habitat for fish cover and wildlife resting areas. It is known to provide nursery, feeding areas and protective cover for panfish and crappies. Ducks were observed. Anglers were also observed. Photos of the area are found in Figures 22 and 23.

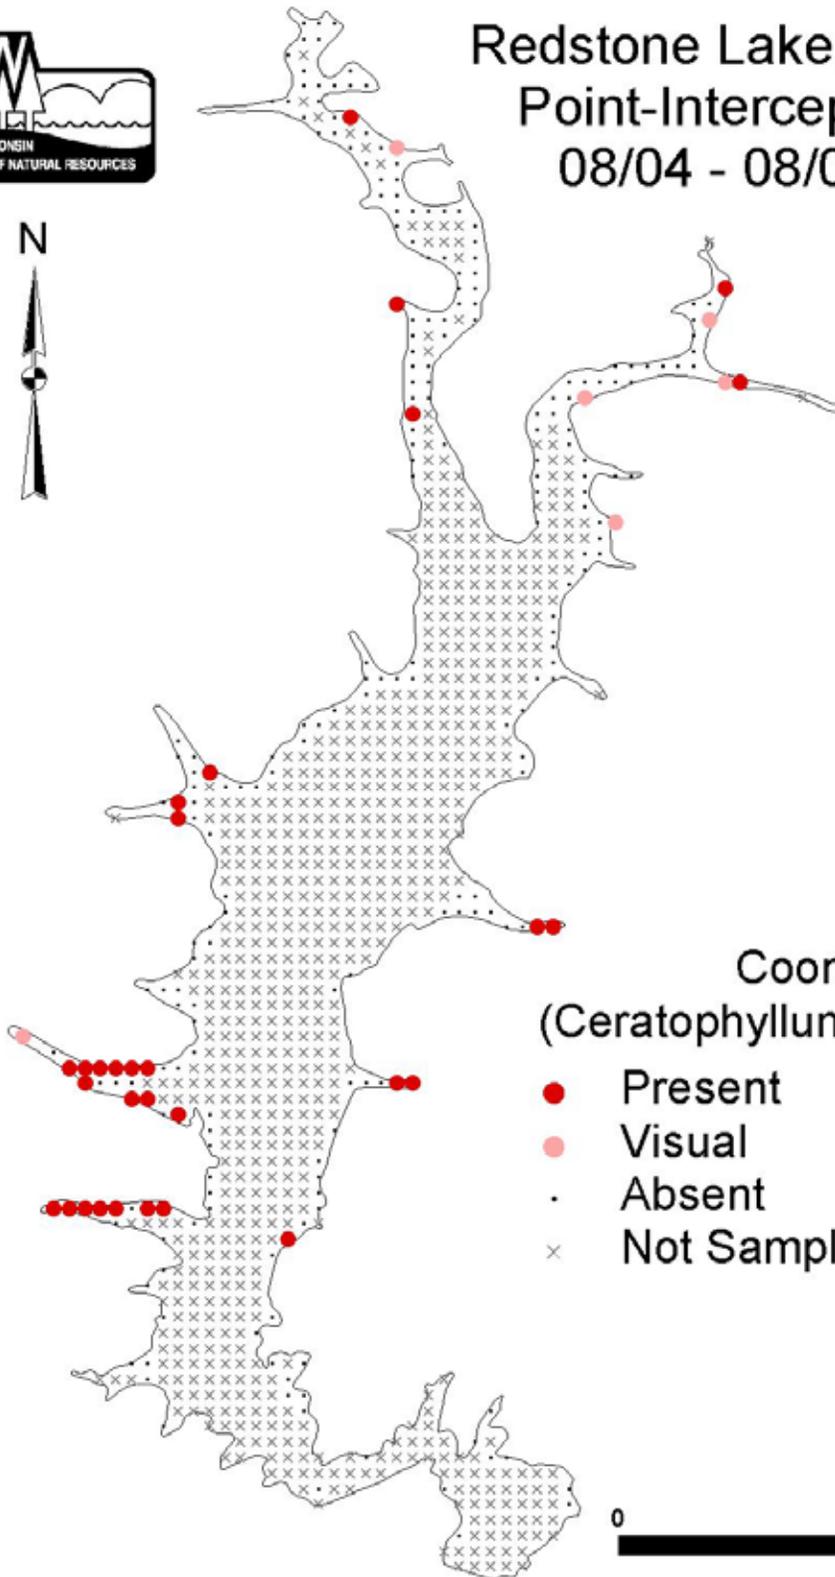
Redstone Lake, Sauk Co. Point-Intercept Survey 08/04 - 08/05/2005

Coontail (*Ceratophyllum demersum*)

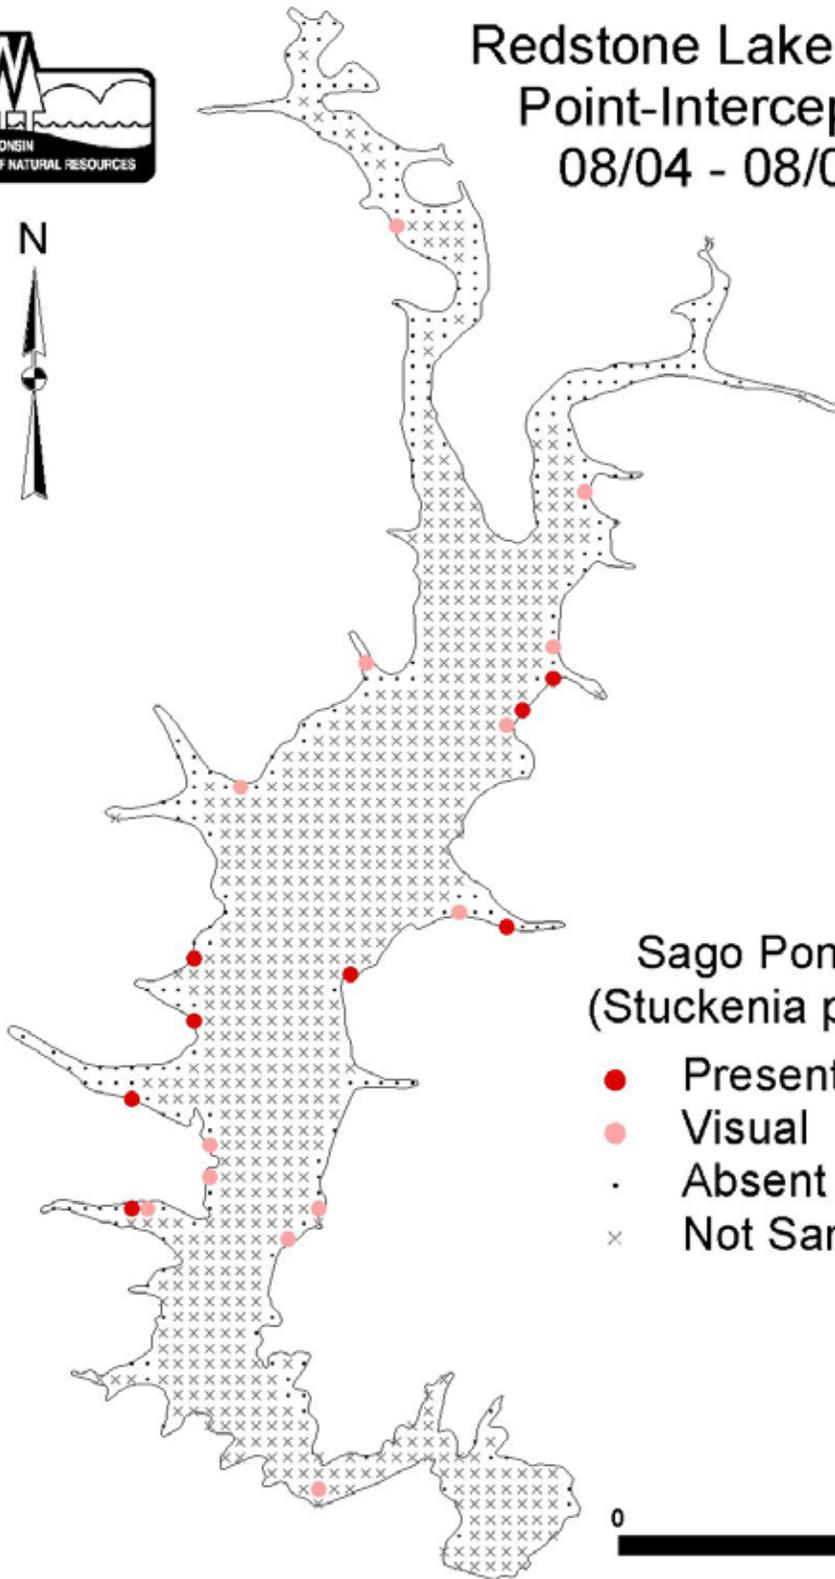
Redstone Lake, Sauk Co. Point-Intercept Survey 08/04 - 08/05/2005

Sago Pondweed (*Stuckenia pectinata*)

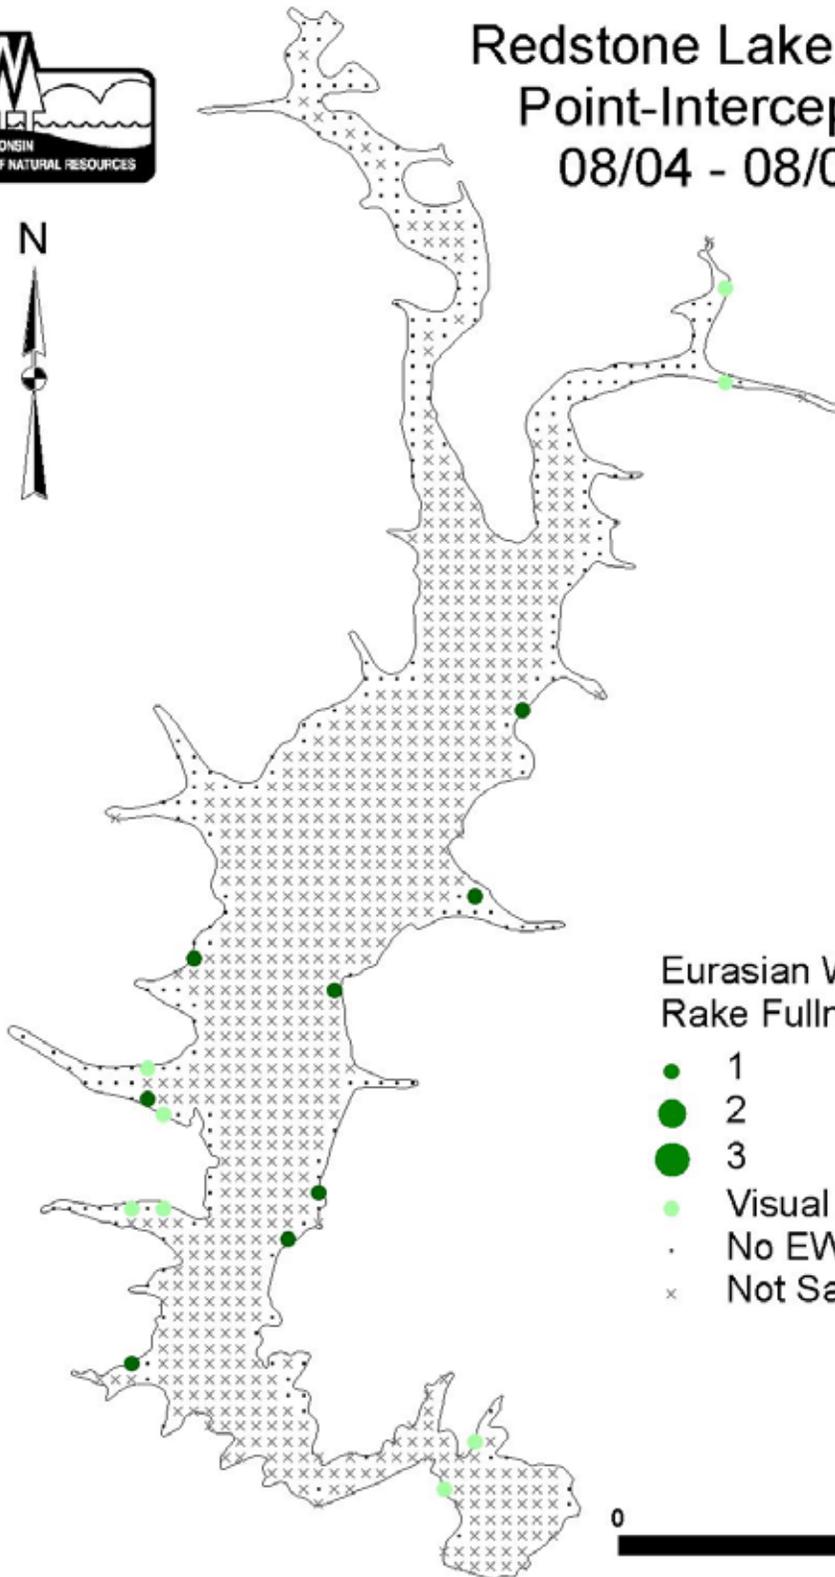
Redstone Lake, Sauk Co. Point-Intercept Survey 08/04 - 08/05/2005

Eurasian Water Milfoil Rake Fullness Rating

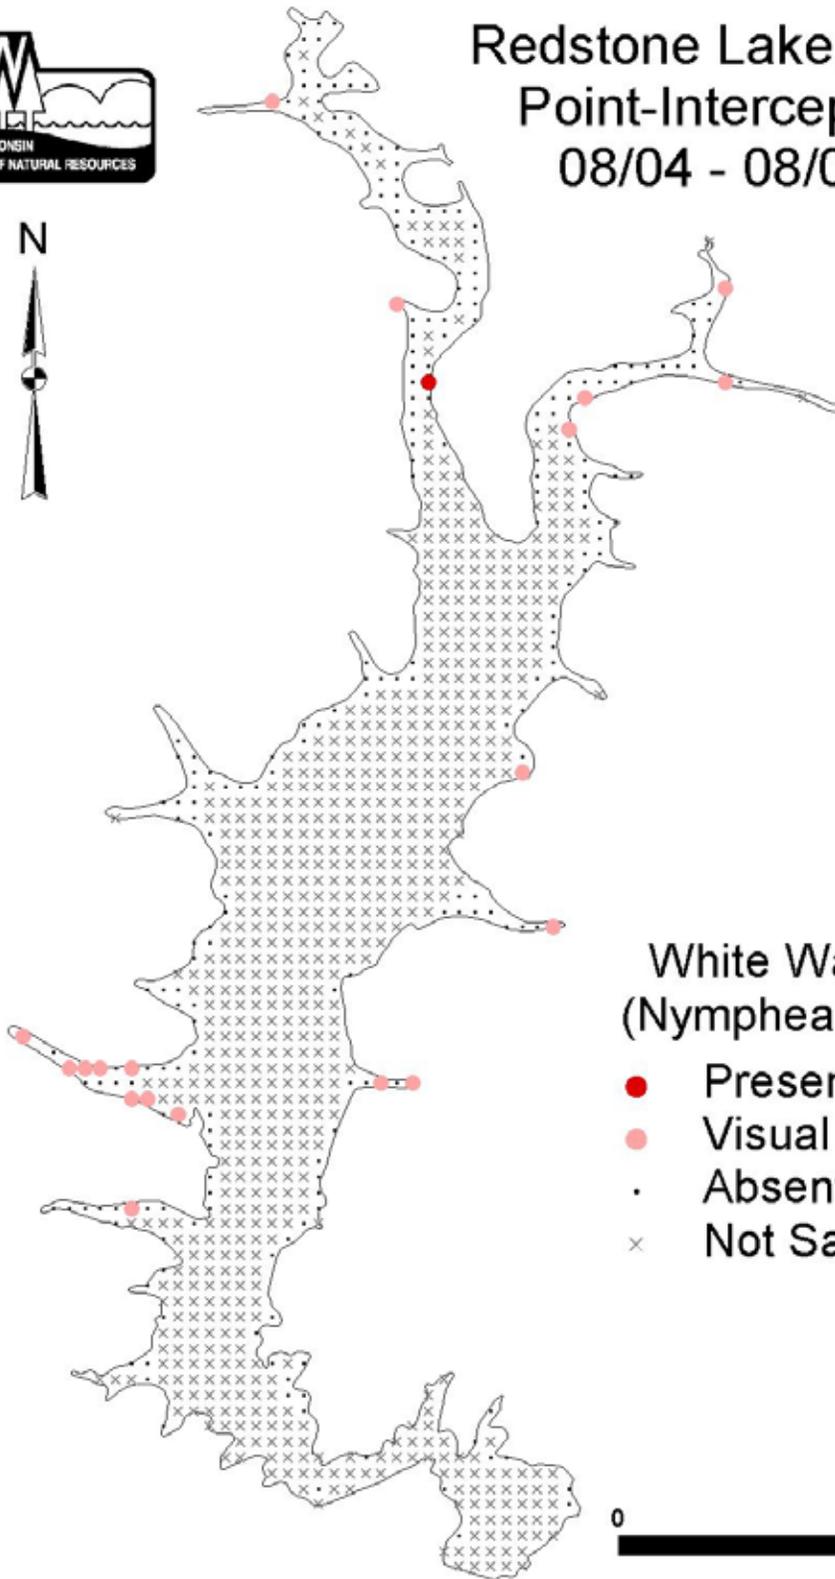
Redstone Lake, Sauk Co. Point-Intercept Survey 08/04 - 08/05/2005

White Water Lily (*Nymphaea odorata*)

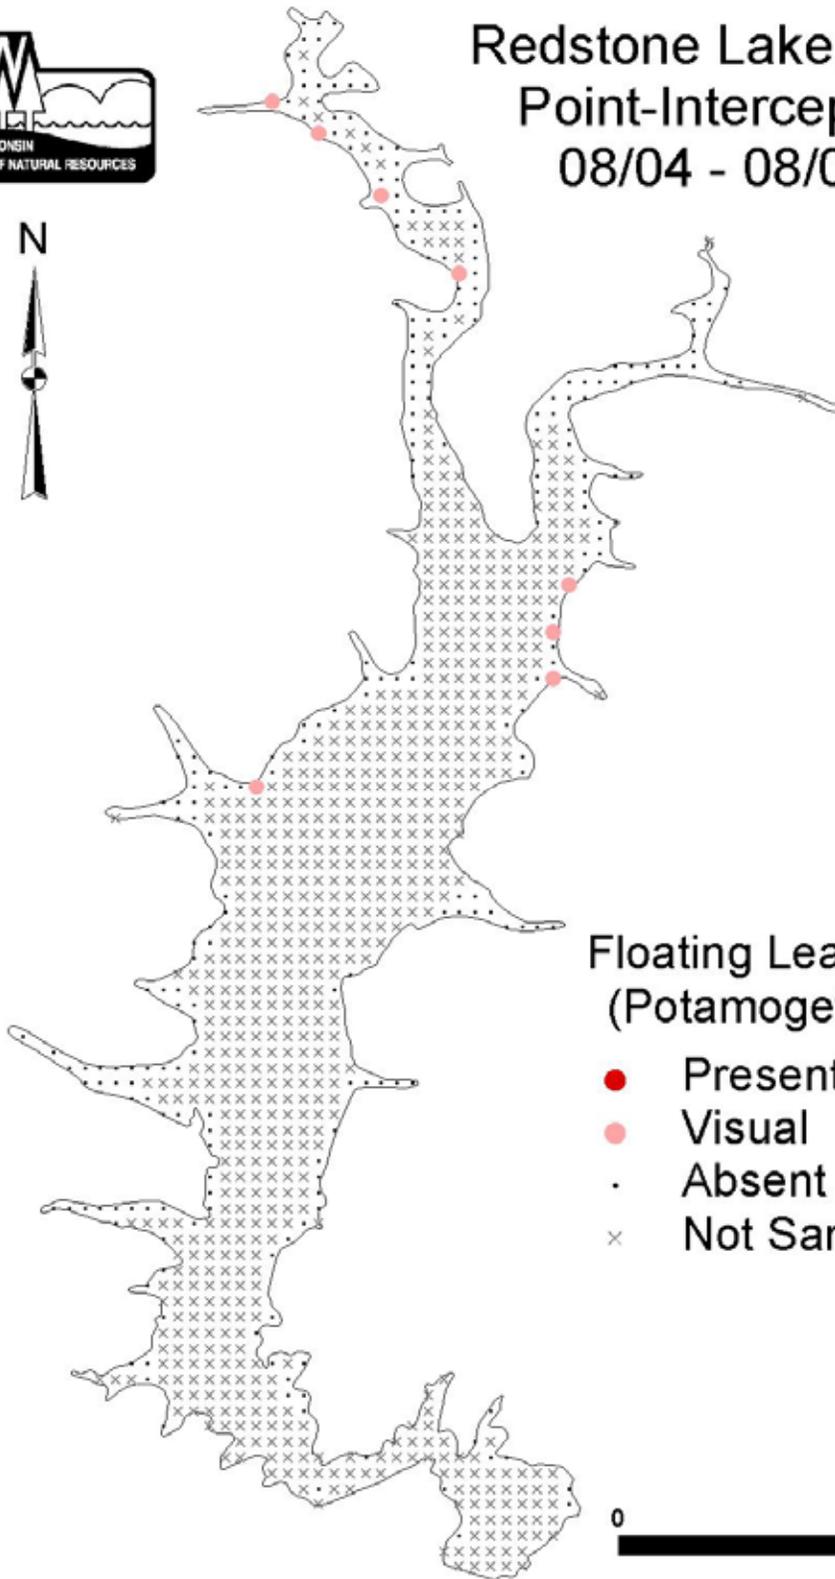
Redstone Lake, Sauk Co. Point-Intercept Survey 08/04 - 08/05/2005

Floating Leaf Pondweed (*Potamogeton natans*)

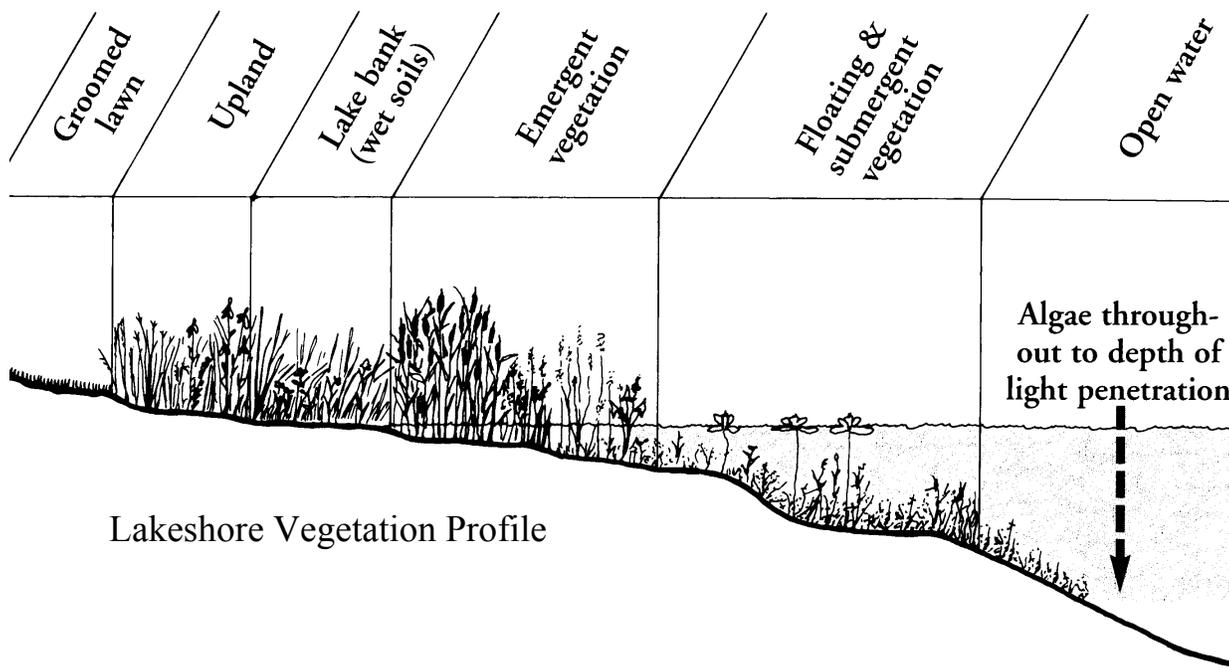
Figure 3. Littoral region of a lake from lake bank to maximum depth of rooted plants.

Within lakes, littoral regions (Figure 3) are extremely important to the structure, function, and integrity of lake ecosystems (Hall and Werner 1977, Gelwick and Matthews 1990, Benson and Magnuson 1992). Evidence suggests that transfer of food energy from the littoral zones of lakes may influence overall fish production and biomass (Boisclair and Leggett 1985). Most lake-resident fish in Wisconsin, including those that inhabit cool- or coldwater offshore habitats in summer in northern temperate lakes, seasonally rely on littoral areas for spawning and rearing (Becker 1983). Moreover, many of these species make diel and seasonal use of littoral regions for foraging (Scott and Crossman 1973, Becker 1983). In addition to species that use these areas seasonally, many species use littoral regions throughout the year, and many use littoral regions throughout their entire life cycle (Becker 1983). The relationships between fish and habitat have been the subject of numerous ecological investigations. The fact that fish are habitat specialists (Gorman and Karr 1978) has been well established by studies conducted in a variety of freshwater habitats. For instance, northern pike require dense mats of short aquatic vegetation in shallow water (< 0.5 m) for spawning (Clark 1950, Forney 1968); fry use these mats during early rearing for protection from predators and for feeding (Franklin and Smith 1963, Frost and Kipling 1967). White suckers, an important native forage fish in Wisconsin, utilize shallow (20-25 cm) gravel substrates in inflowing or outflowing streams or in shallow, nearshore littoral regions of lakes (Krieger 1980). Yellow perch broadcast strands of eggs in shallower water (1-3 m) where moderate levels of vegetation help capture the egg strands and increase their potential survival (Clady and Hutchinson 1975).

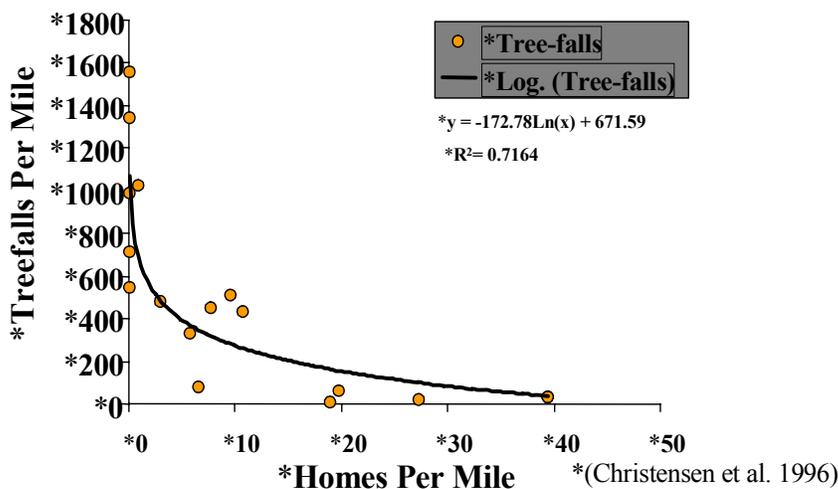
Figure 4. Impacts of Residential Development on Treefalls into Lakes.

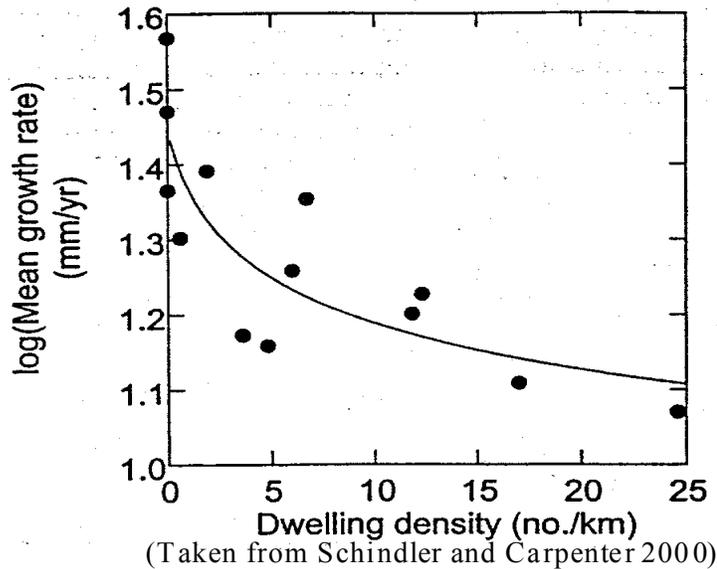
Figure 5. Development Impacts on Bluegill Growth Rate.

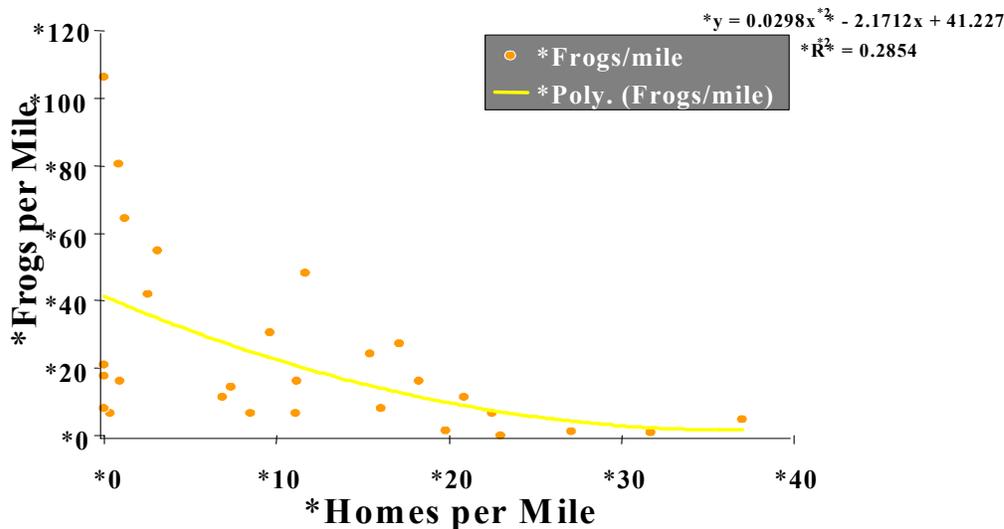
Figure 6. Response of Green Frog Populations to Lakeshore Residential Development
