# **LAKE REDSTONE PROTECTION DISTRICT PARTNERS MEETING**

**OCTOBER 29, 2025**

# STATUS OF 9-KEY ELEMENT PLAN IMPLEMENTATION

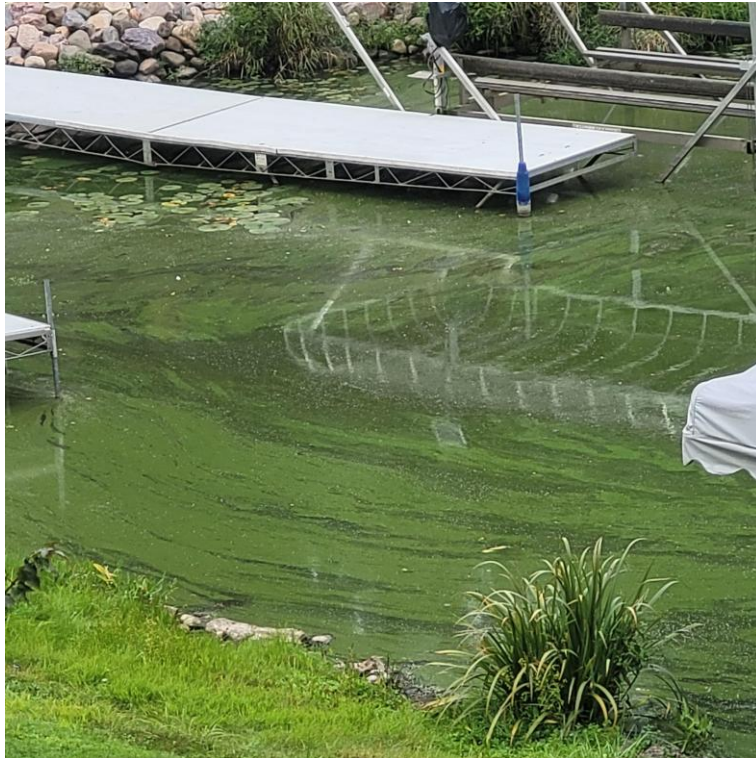
Chickadee Bay North

Positive jar test

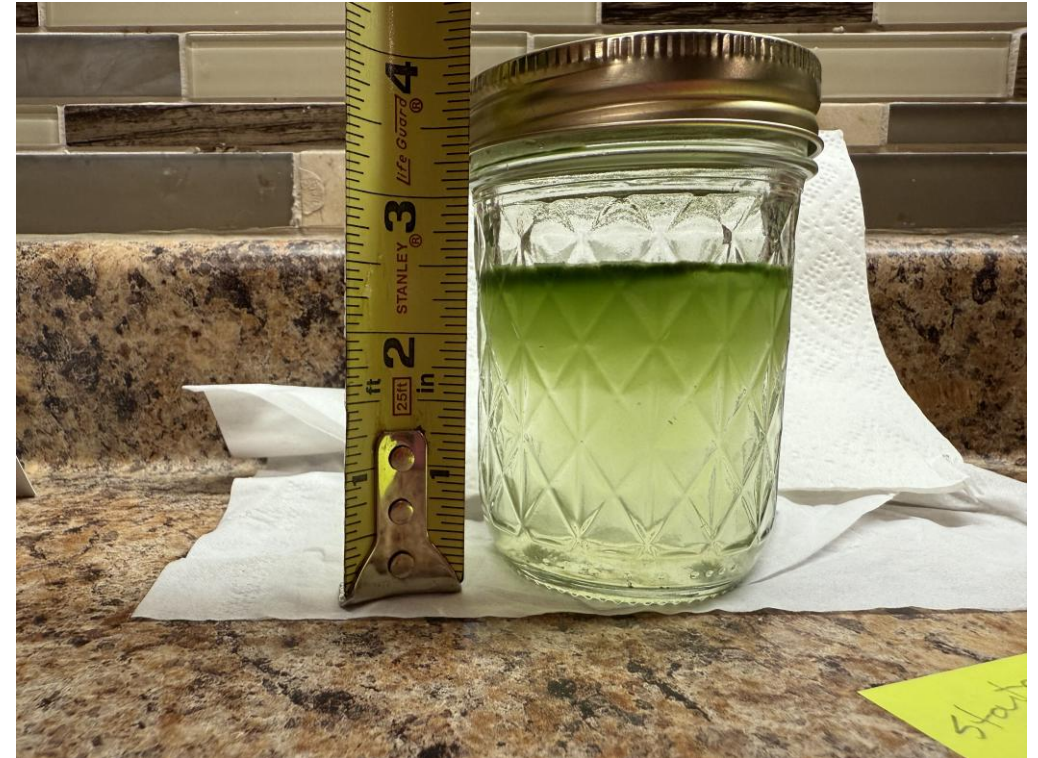
Harmful Algal Bloom confirmed by DHS based on photos

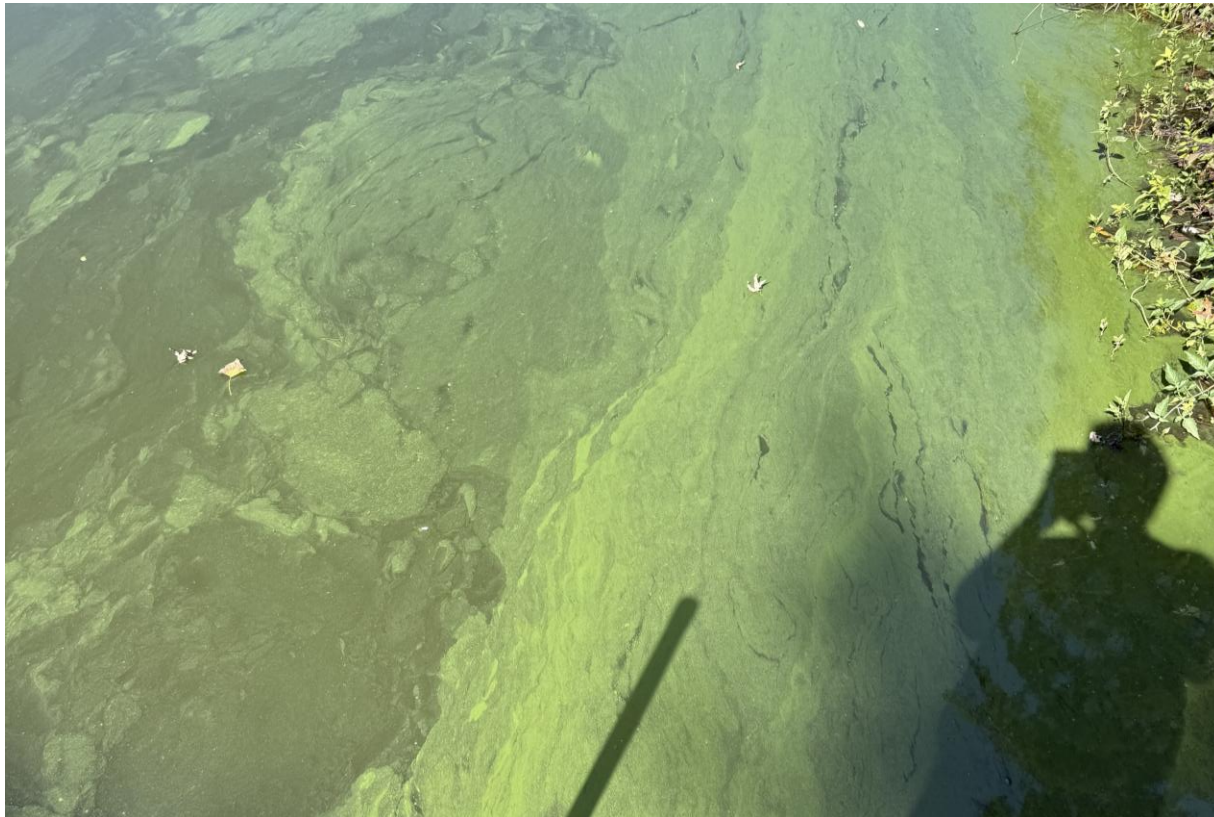
Chickadee Bay North

# Cyanobacteria bloom, Sept 26, 2025

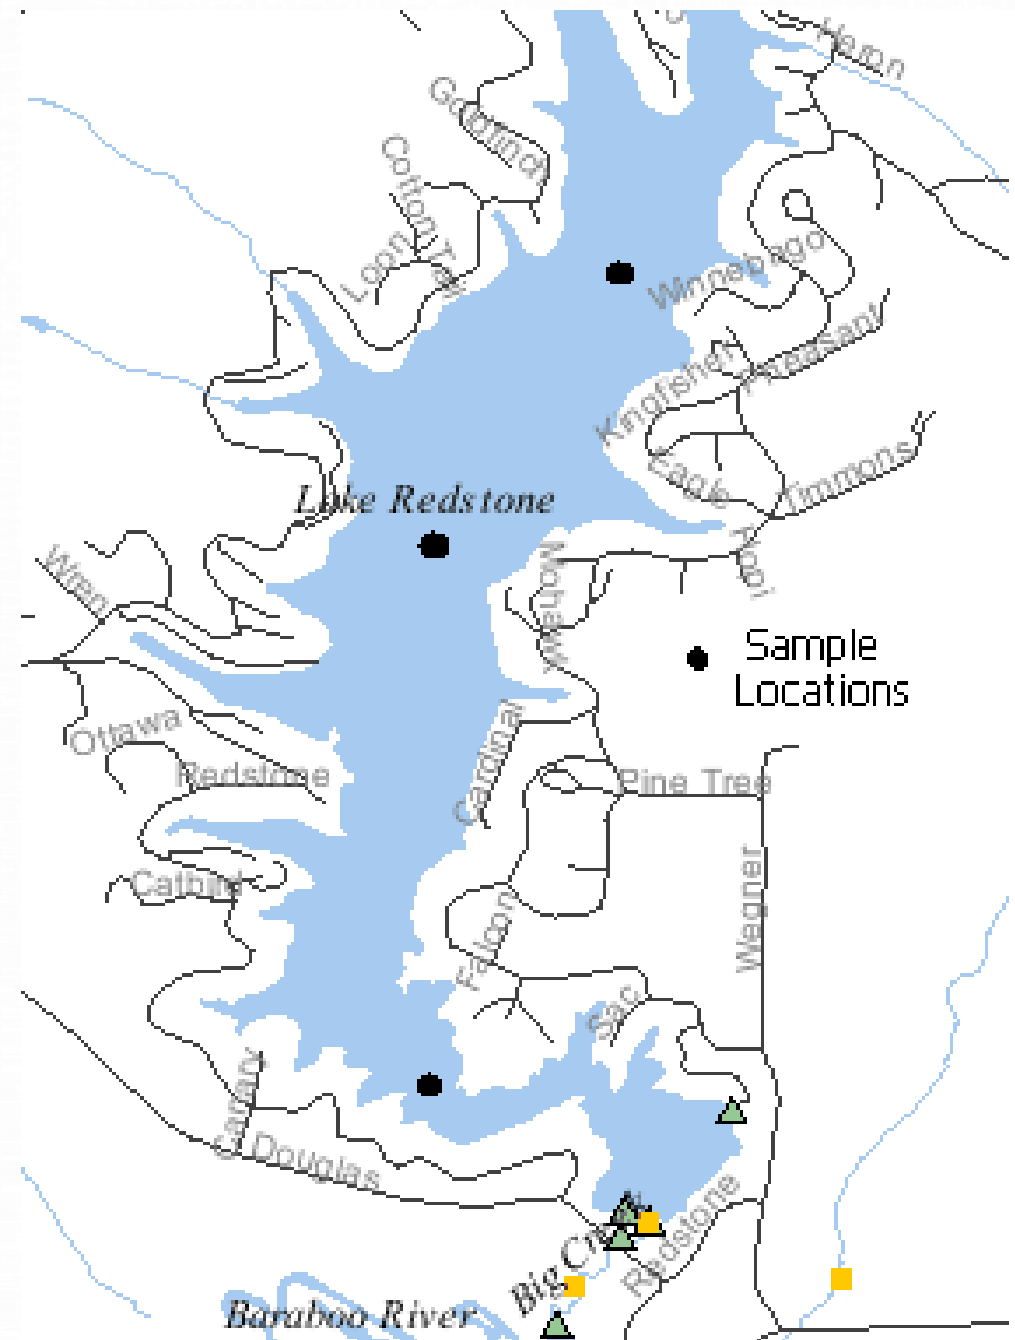
## Water monitoring in Lake Redstone

Several parameters, including total phosphorus have been measured for more than 20 years.

For many years, total phosphorus was measured near surface (2 ft down ) and near the bottom (2 ft up)
