Aquatic Plant Management Plan for Lake Redstone Sauk County, Wisconsin

2023-2028

Plan approved May 25th, 2023

*Prepared for the Lake Redstone Protection District
Funded in part by WDNR Aquatic Invasive Species Planning Grant AEPP64522*

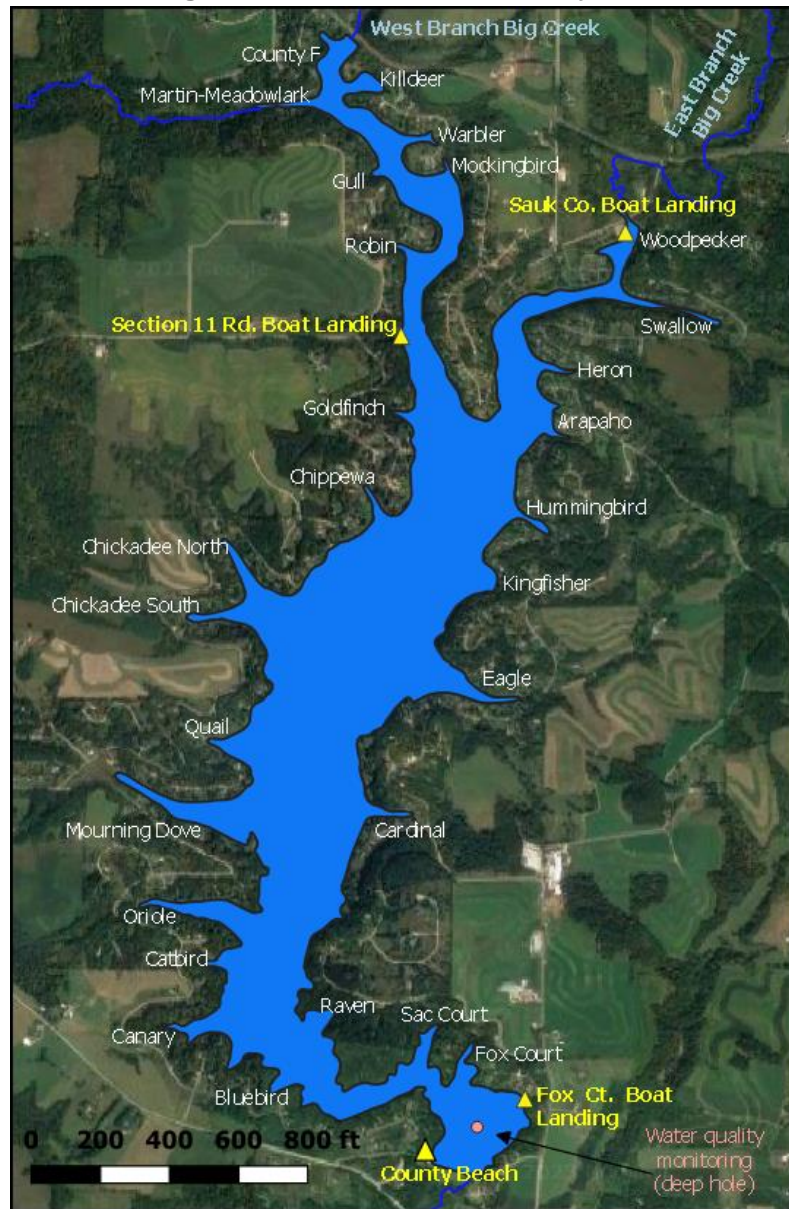
Figure 1 - Lake Redstone Study Site

Lake Redstone (WBIC 1280400) is located in the Town of La Valle in northwestern Sauk County, Wisconsin. The lake is an impoundment of West and East Branches of Big Creek, although other intermittent streams also flow into the lake. Waters flow over a top draw dam at the southern end directly into Big Creek for a short stretch before flowing into the Baraboo River (Figure 2). Lake Redstone was created in the 1960's with the intent of created >1500 lots for development. The lake's surface area is 635 acres, maximum depth is 36.5 feet, mean depth is 14 feet, and the shoreline length is 17.5 miles.

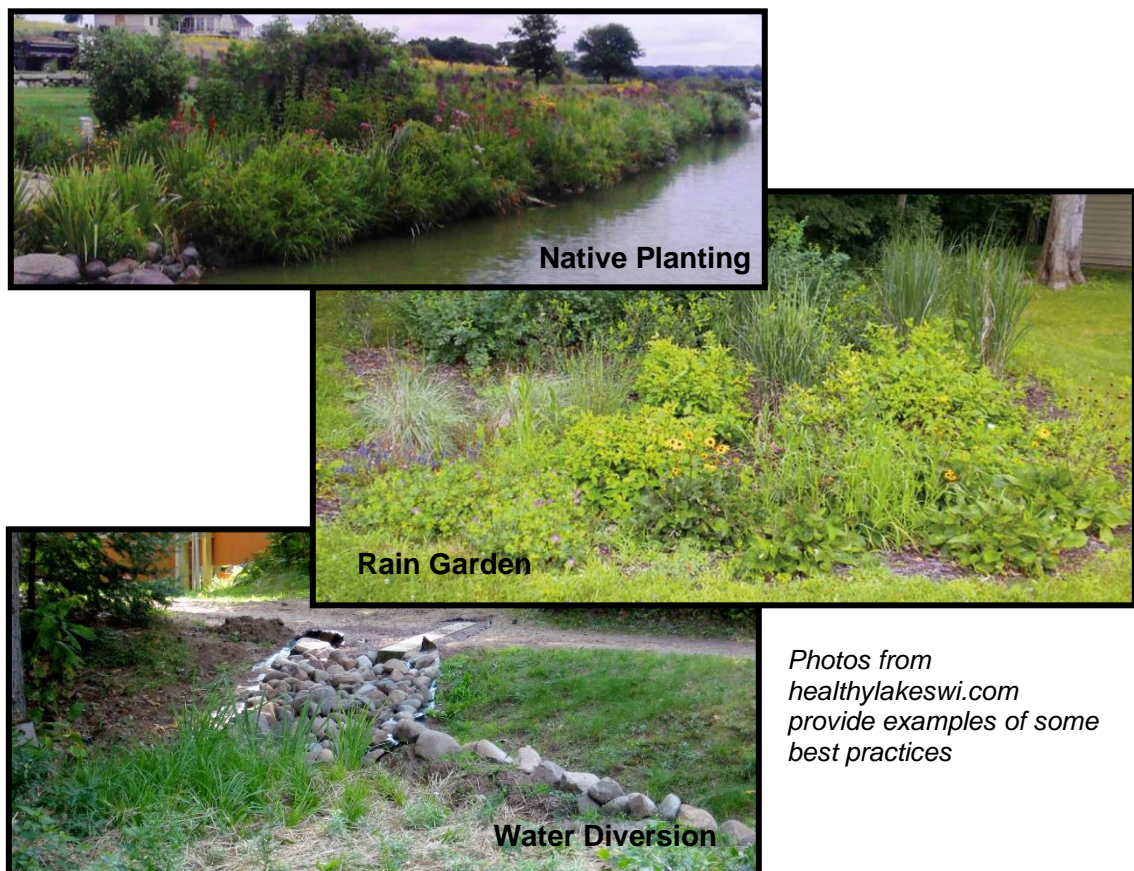
Figure 5 – Healthy Lakes Practices

Sauk County Land Resources and Environment Department may also provide cost share funding limited to 50% of the project cost up to \$2,500. Eligible projects reduce sediment loads in Sauk County and may include vegetated buffers, bioengineering with natural fiber products (e.g. natural fiber rolls and logs, blocks, and mats), wave-reducing natural timbers, and rock riprap with bioengineering techniques (e.g. rock riprap with native plantings, geotextile bags, geogrid lifts, and synthetic engineered matting). More information is available at <https://www.co.sauk.wi.us/landconservation/lake-programs>

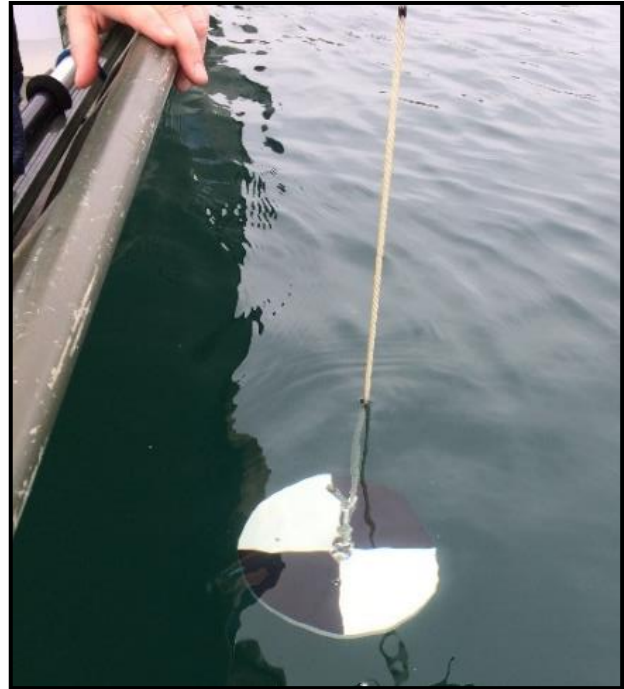
Figure 7 – Secchi Disk

The depth to which light can penetrate, or water clarity, is a factor that limits aquatic plant growth. Water clarity is measured by lowering a black and white Secchi disk (8 inches diameter) in the water and recording the depth of disappearance. The disk is then lowered further and slowly raised until it reappears. The Secchi depth is the mid-point between the depth of disappearance and the depth of reappearance. Because light penetration is usually associated with nutrient levels and algae growth, a lake is considered eutrophic when Secchi depths are less than 6.5 feet. Secchi depths vary throughout the year, with shallower readings in summer when algae concentrations

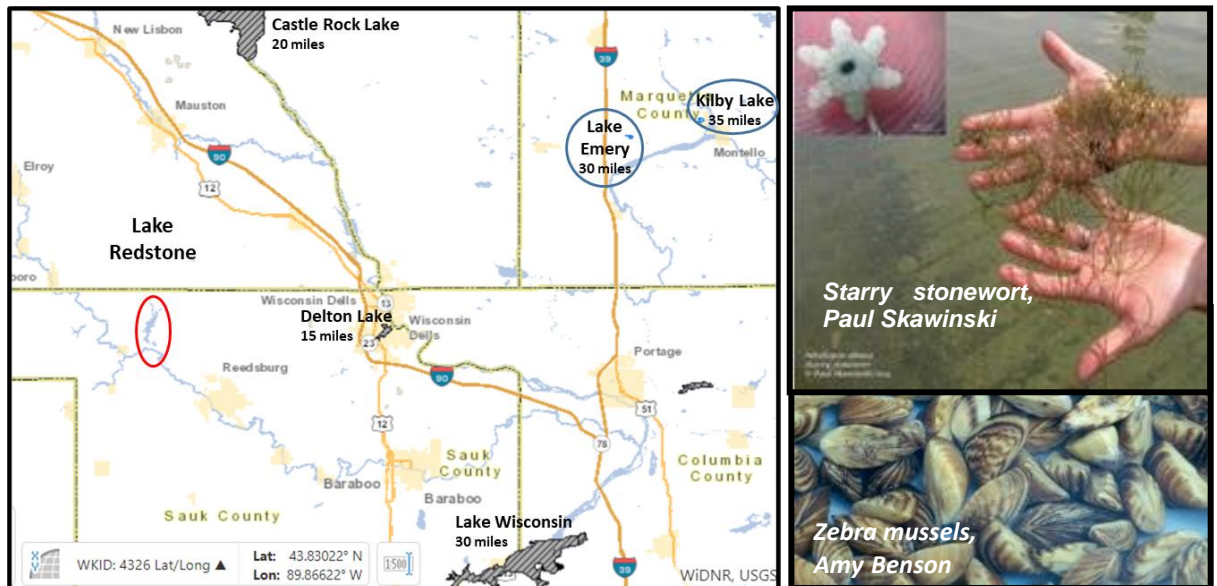
Figure 18 – Nearest Lakes with Starry Stonewort & Zebra Mussels

The invasive species of greatest concern for introduction into Lake Redstone are stony starwort (*Nitellopsis obtusa*) and zebra mussels. These are not the only nearby invasive species. However, steps taken to prevent the introduction of starry stonewort and zebra mussels will help prevent the introduction of other invasive plants and animals. Starry stonewort looks like an aquatic plant but it is actually a type of macro algae. It can outcompete other vegetation and forms monotypic stands that may reduce fish spawning habitat. The nearest waterbodies with verified starry stonewort are Lake Emery and Kilby Lake located approximately 30-35 miles northeast of Lake Redstone and near Montello (Marquette County). The nearest waterbodies with verified zebra mussels are Castle Rock Lake, Delton Lake, and Lake Wisconsin. A single zebra mussel was found in nearby Dutch Hollow Lake in 2022 but continued monitoring is needed to know whether there is an established population. The proximity of these lakes with invasive species is relevant because boats leaving a lake with AIS can introduce the plants or animals into other lakes if proper prevention steps are not taken (see section 3.0 on AIS prevention).

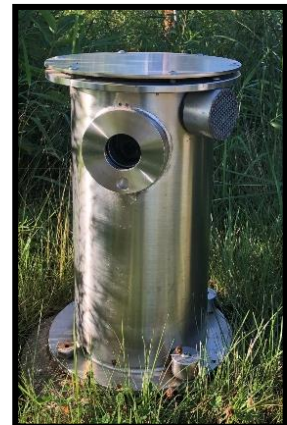
Figure 21 – I-LIDS Photo

Even when a watercraft inspector is not present, boat launching activities can be recorded by a motion-activated camera and reviewed by paid interns, volunteers, or other workers in order to detect whether a boat was launched with aquatic plants attached to a trailer, which is illegal in Wisconsin. Boaters are more likely to comply with watercraft inspection requirements when the I-LIDS system is in place (Figure 21). This device is not currently installed at any public boat landing in Lake Redstone. The device is solar powered and requires Verizon 4G data service onsite. Cost of device, materials, and installation is approximately \$16,000 and annual cost of operation of approximately \$2,500. Grant funding is available to help pay for initial costs, but not annual costs.⁵

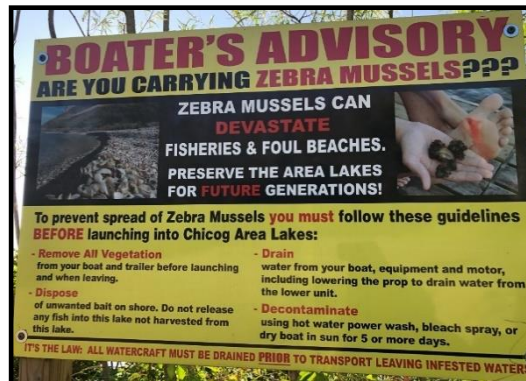
Figure 23 – Zebra Mussel Advisory Sign

There are many different signage options intended to capture boaters’ attention and increase compliance with watercraft inspection steps. Figure 23 illustrates one such sign where there have been heightened efforts to prevent zebra mussels from spreading to other lakes in the area.

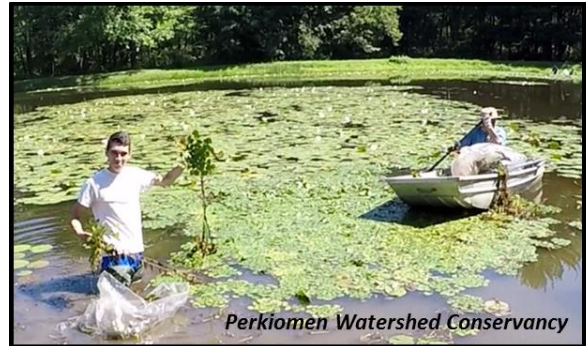
Figure 25 – Manual Removal Photo

Shore land property owners are allowed to manually remove a 30-foot wide section of native aquatic plants parallel to their shoreline without a permit. This can only occur in a single area and there must be piers, boatlifts, swim rafts, or other recreational or other water use equipment within that 30-foot zone. This method can only be employed where other plant

control methods are not being used. Regulations require that the native plant community is not harmed during manual removal of AIS. Benefits of include little overall damage to the lake and plant community, the removal can be highly selective, and can be very effective in in small clusters of EWM. On the other hand, this method can be very labor intensive. **Manual removal in Lake Redstone is feasible for small-scale control around docks, boat lifts, and other water use equipment. Manual removal is also feasible to complement herbicide treatment one year later. Permits are required for manual removal in critical habitat areas** (Figure 15).

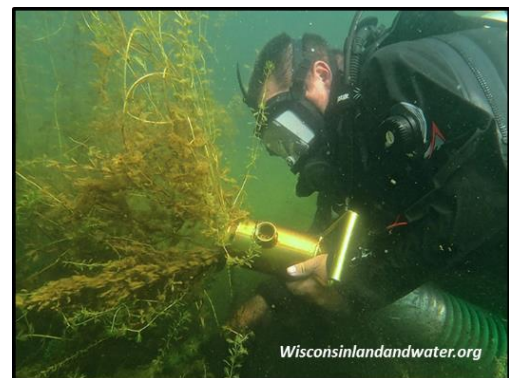
Figure 26 – DASH Photo

This form of mechanical removal involves the use of suction tubes connected to pumps mounted on a barge or pontoon. The suction tubes reach to the bottom of the lake and SCUBA divers manually uproot plants (often EWM) to be sucked through the tubes, up to the barge, and strained. DASH is also selective toward EWM thereby protecting native and low frequency species and can be highly effective. DASH is labor intensive and costly at \$2,500-\$3,000 per day and speed of removal depends on density, EWM height, and the number of different locations. **Continuing DASH to control EWM is feasible in small infestation sites, perhaps to be hired independently by lakeshore property owners. DASH is also feasible to complement herbicide treatment one year later, which is often a good integrated approach.**

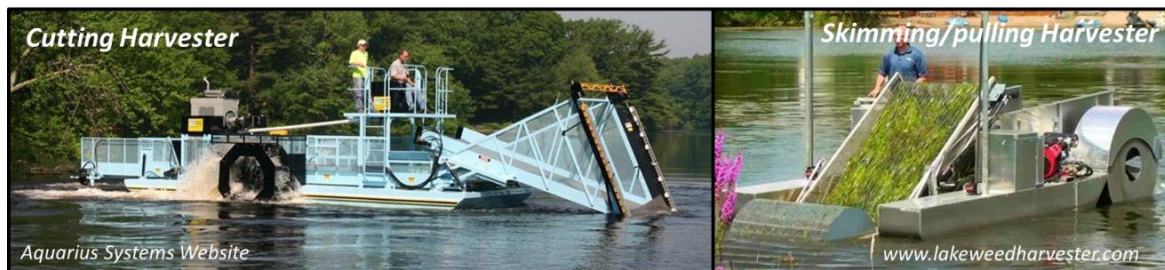
Figure 27 – Mechanical Harvester Photos

This method includes “mowing” of aquatic plants down to depths of 5 feet and then collecting the plants and removing them from the lake. Mechanical harvesters are required to operate in depths of 3 feet or greater in order to minimize sediment disturbance in shallow areas. This technique is most appropriate for lake systems with large-scale or whole-lake aquatic plant issues. ***Mechanical harvest is not a feasible option for Lake Redstone due to the low aquatic plant occurrence and near-shore location of EWM beds.***

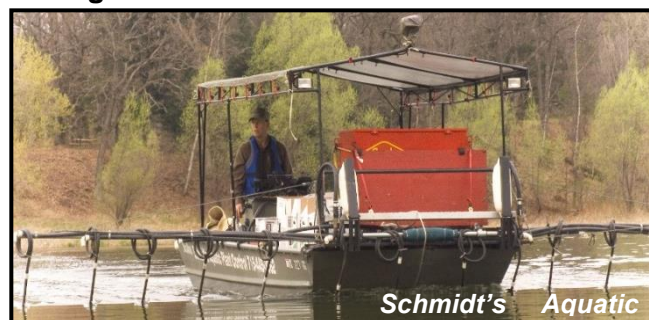
Figure 28 – Chemical Treatment Photo

This method entails partnering with a certified herbicide applicator that will follow label guidelines and restrictions. There are herbicides intended to target specific plant species. For EWM control, an herbicide generally known as 2,4-D is often used because it is supposed to be selective to broadleaf plants such as milfoils.

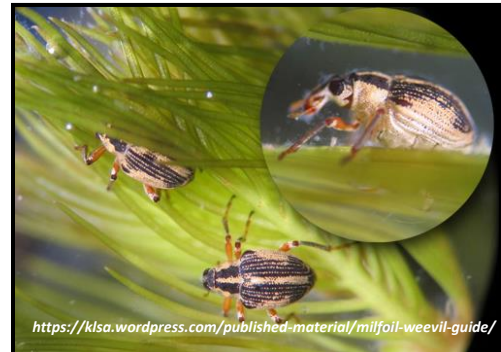
Figure 29 – Milfoil Weevil

If biological control were to be pursued, the first step would be to determine whether the native weevils are already naturally present and in what densities.
