Lake Redstone, Sauk County
2022-32 9-Key Element Watershed and
Lake Management Plan
Appendices
January 2022

Appendix B
Strategic Lake Management
Planning Review

Lake Redstone

WBIC. 1280400
DNR No. SPL-362-16

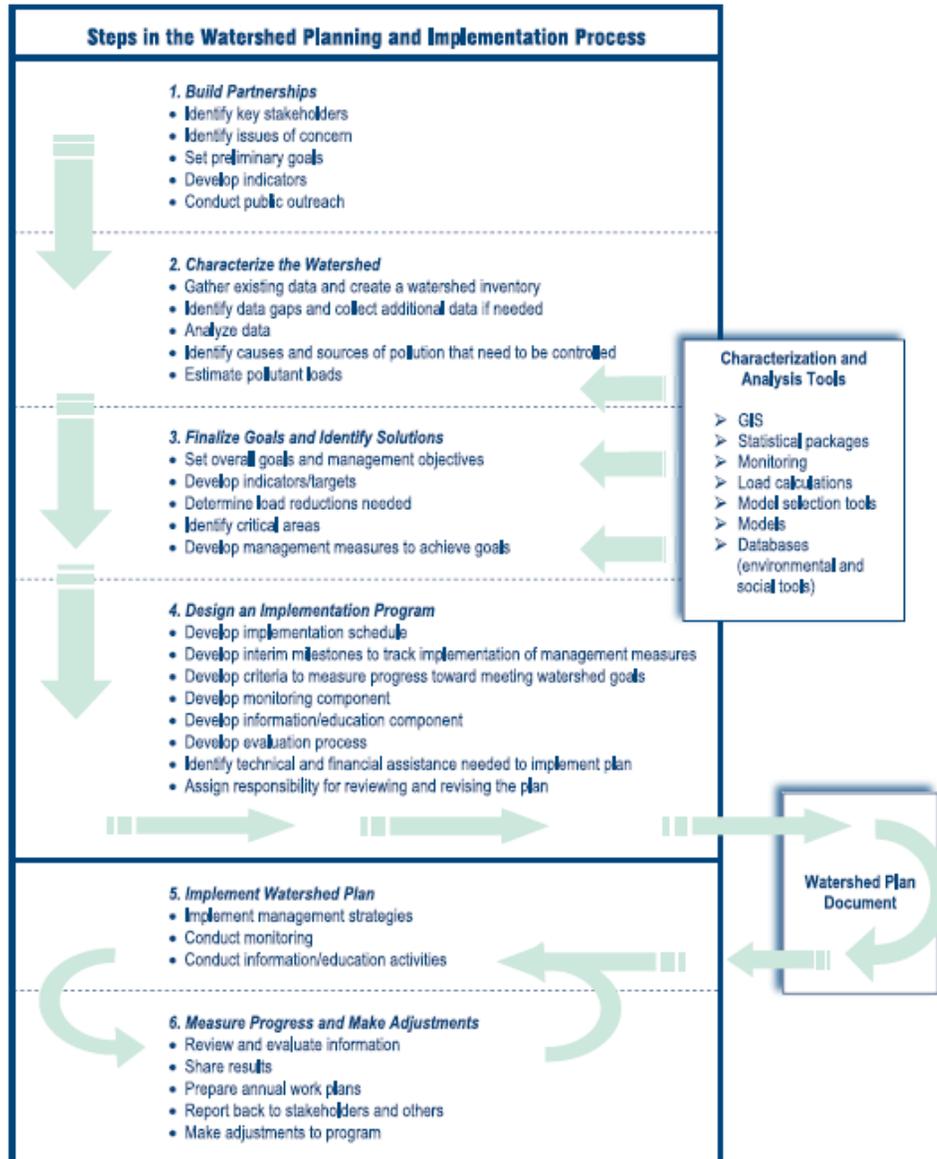
Figure 1 – Steps in Watershed Planning and Implementation (United States Environmental Protection Agency, 2008)

In 2008, the EPA published a guide for developing watershed plans (United States Environmental Protection Agency, 2008). The process outlined in this document is fully supported by the WDNR. There are six steps for watershed planning and implementation included in this document (Figure 1). Each step has several tasks associated with it. Within the six steps and their associated tasks are nine key elements that are critical for achieving improvements in water quality. These 9-Key Elements are required in watershed plans that are federally funded with Clean Water Act Section 319 funds, but also strongly recommended for all other plans to address water quality impairments.

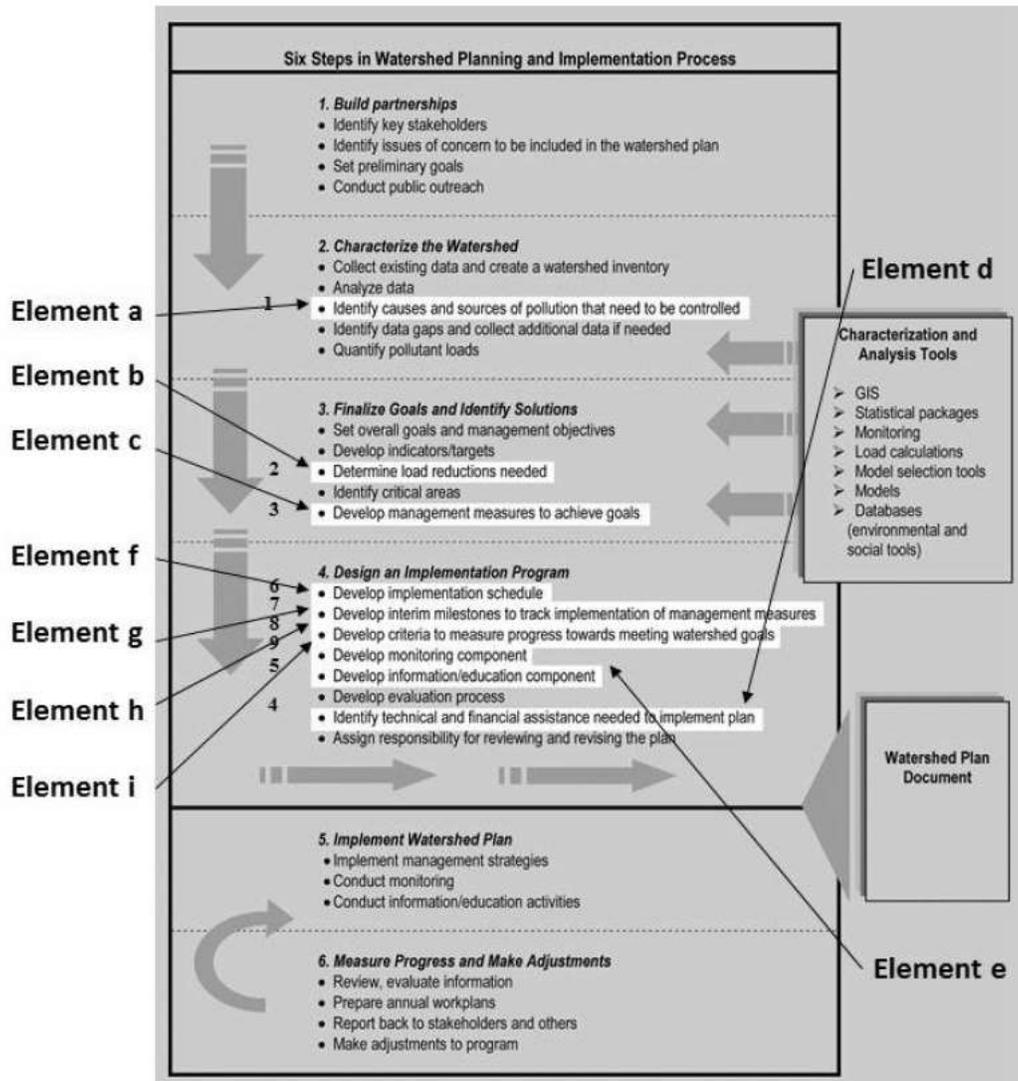
Figure 2 - Crosswalk between the six steps of watershed planning and the section 319 nine minimum elements (EPA, 2013)

These nine elements are embodied within the six steps of the watershed planning and implementation process (Figure 2).

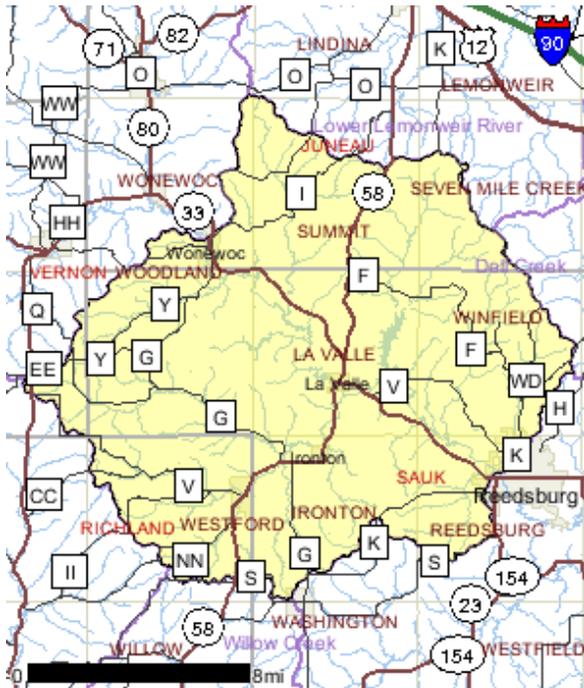
Figure 3 - Crossman Creek and Little Baraboo River Watershed

Lake Redstone is located in the Crossman Creek and Little Baraboo River watershed which is 213.80 mi² (Figure 3). The Crossman Creek and Little Baraboo River Watershed lies in northwestern Sauk County, southern Juneau County, northeastern Richland County, and the southeast corner of Vernon County. It is also in the Driftless, or unglaciated region of Wisconsin. The watershed includes the main stem of the Baraboo River from Wonewoc to Reedsburg. Land use in the watershed is primarily agricultural (60%), forest (31%) and a mix of suburban (6%) and other uses (4%) (Figure 4). This watershed has 466.61 stream miles, 244.11 lake acres and 6,321.59 wetland acres. The watershed is ranked high in both overall nonpoint source pollution and groundwater nonpoint source pollution; however it is expected that these sources can be controlled with best management practices.

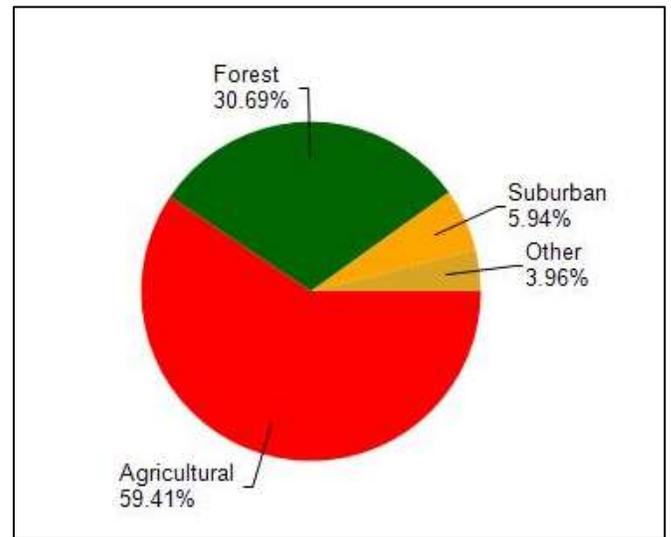
Figure 4 – Land Use in the Crossman Creek and Little Baraboo River Watershed

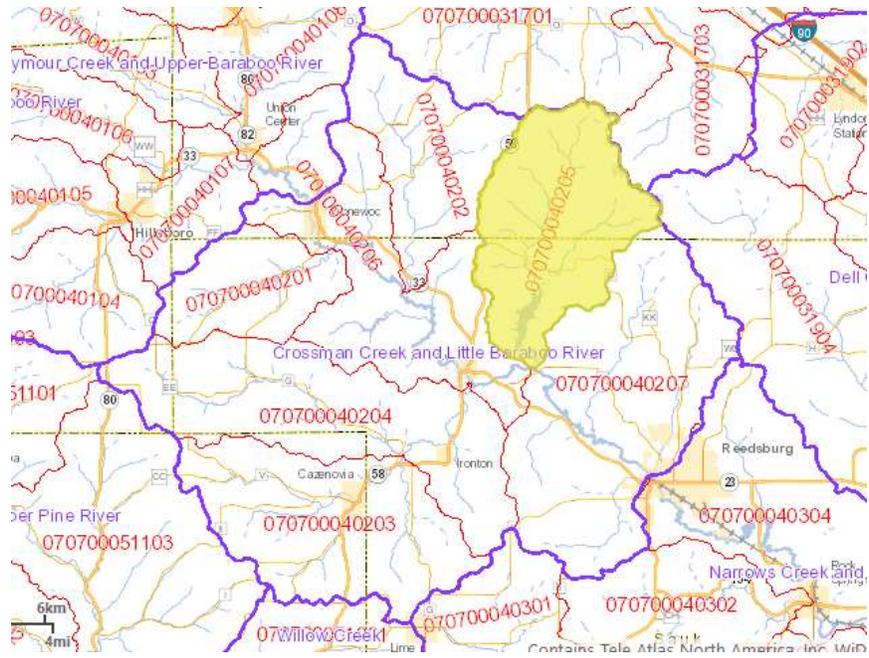
Figure 5 – Direct watershed of Lake Redstone (WDNR, 2016)

The direct watershed of Lake Redstone (Figure 5) is a smaller, sub-watershed within the larger Crossman Creek and Little Baraboo River Watershed. It covers approximately 30 square miles, most of which is in Juneau County. Because of the problems associated with nonpoint source pollutions, the watershed of Lake Redstone has been the focus of many studies identifying causes and sources of pollution that need to be controlled (9-Key Element) and projects implemented to reduce sediment and phosphorus loading. These projects will be inventoried in the next section of this report.

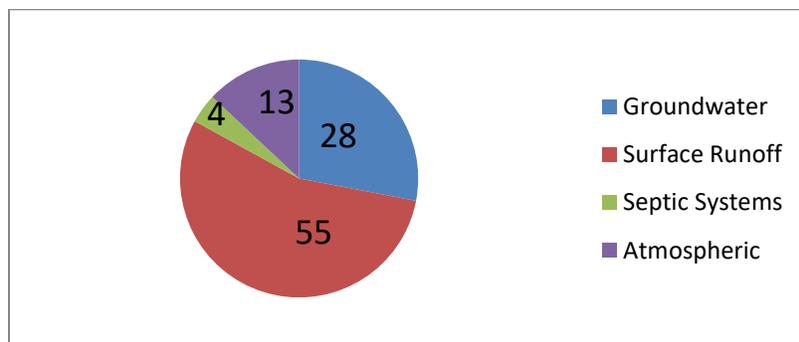
Figure 6 – Phosphorus Budget in 1981 (Institute for Environmental Studies, 1981)

The first major study of the lake was completed in 1981 by the University of Wisconsin (UW)-Madison Water Resources Management Program, Institute for Environmental Studies (Institute for Environmental Studies, 1981). The purpose of the UW Study was to identify the causes of nutrient and sediment overloading that had created water quality problems; and to prevent management alternatives designed to restore and protect the lake. The analysis included both technical data and perceptions of the area residents. This was the first public use survey of the residents of the lake, and the first serious look at sources of phosphorus and sediment to the lake. Figure 6 shows the breakdown of phosphorus loading from various sources identified during the UW Study.

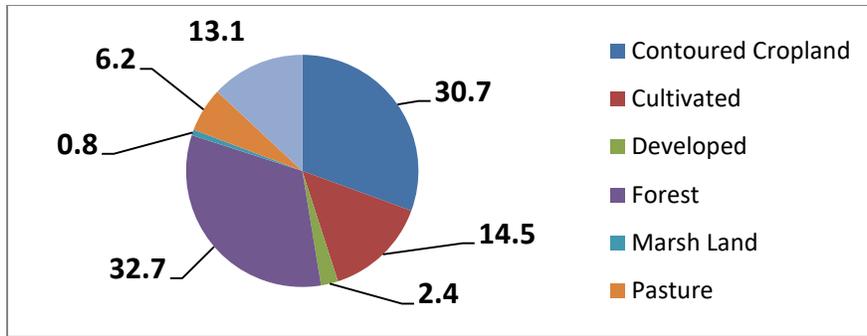
Figure 7 – 1981 Land Use (Institute for Environmental Studies, 1981)

Land use in the watershed was inventoried during the UW Study with nearly 65% involving agriculture including contoured cropland, cultivated, pasture, and pastured woodlots (Figure 7).

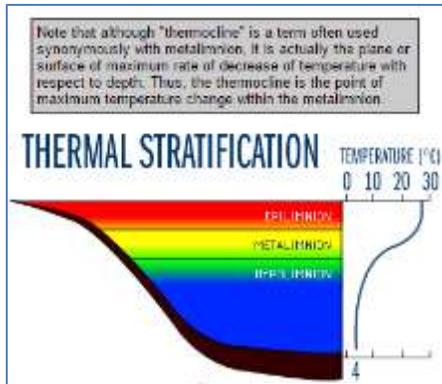
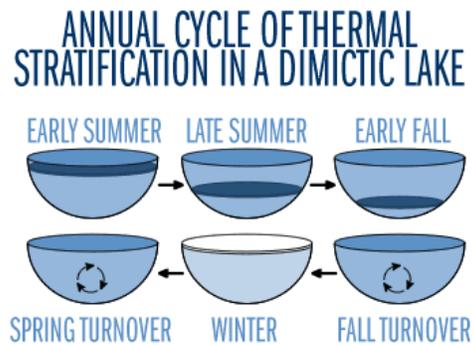
Figure 8 – Thermal Stratification and lakes (University of Minnesota - Duluth, 2016)

During the summer months colder water sinks to the bottom and warmer water rises to the surface. The two layers of water are separated to some degree by a "thermocline", defined as the depth of water at which the temperature changes the most rapidly over a very short depth interval, typically a few inches to a few feet (Figure 8). This generally occurs in deep lakes in WI only during the warm summer months. In both the spring and fall water temperatures throughout the water column of the lake become similar. In the spring the water temperature directly under the ice is about 32°F, while the water temperature at the bottom of the lake is about 40°F. Warming in the spring melts the ice and warms up the water until it is the same top to bottom. In the fall, water is warmer at the surface of the lake than it is in the bottom of the lake. Cooling temperatures reduce the surface water temperature until once again the water temperature is the same top to bottom. In both of these cases, when water temperature is the same top to bottom a mixing event occurs throughout the lake. A lake that does this is called a dimictic lake. The spring and fall mixing events are called "turnover" (Figure 8). During turnover, some good things happen like adding oxygen to the water so fish can survive, but also some bad things happen like adding excess nutrients back into the water that may fuel algae blooms.

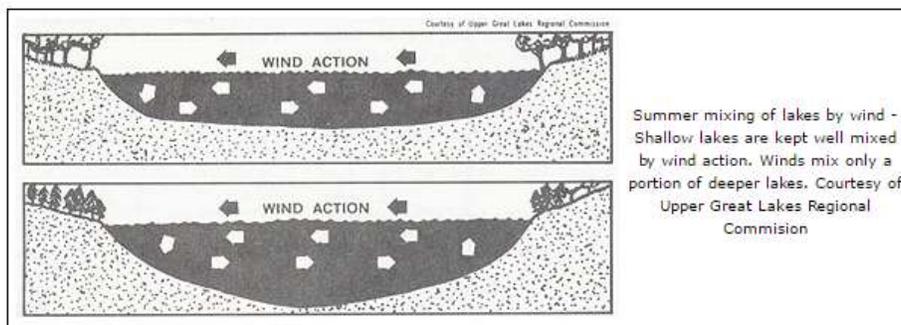
Figure 9 – Summer mixing in shallow and deep lakes (Grovhac, Inc., 2016)

Shallow lakes in Wisconsin will often remain “mixed” throughout the summer season; or stratify for short periods only, then mix again. Mixing means that water temperatures at the surface of the lake and at the bottom of the lake never really establish enough of a temperature change to stratify, or only do so for a very short period of time before stratification falls apart. Lakes that stratify and de-stratify numerous times within a summer are known as polymictic lakes. Data collected in 2000 show that Lake Redstone only remains stratified for the whole summer in the deep water area adjacent to the dam. In all other parts of the lake, mixing caused by wind and wave action (natural and those caused by boats) occurs frequently (Figure 9). During the summer this mixing adds phosphorus to the surface waters of Lake Redstone promoting additional algal growth.

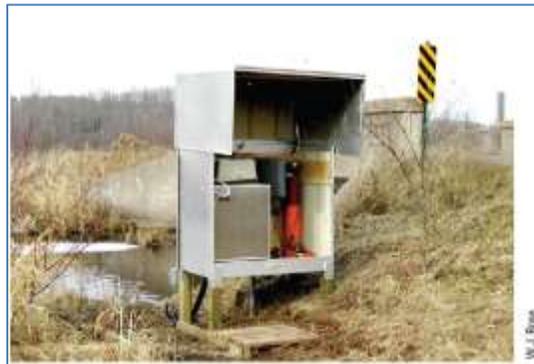
Figure 10 – Typical U.S. Geological Survey recording streamflow-gaging station with automatic water sampler for load determinations (Garn, Elder, & Robertson, 2003).

Surface water inflow and outflow may be determined by recording streamflow-gaging stations (Figure 13) near the mouths of major tributaries and at the lake outlet. Surface water flows can also be sampled and analyzed for phosphorus and sediment concentrations. Streamflow data, along with the concentration data, are used to determine the annual phosphorus inputs and losses. It is recommended that this level of streamflow data be collected on the East and West branches of Big Creek.

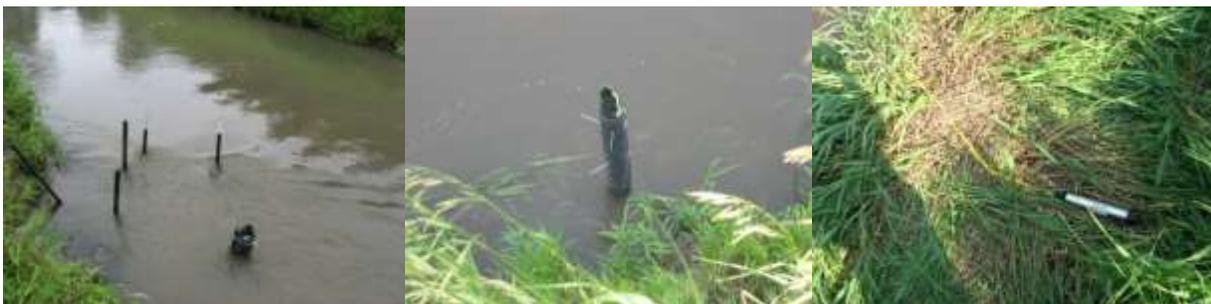
Figure 11 – Installation of pressure transducers (data logger) to measure depth of water (Papanicolaou, 2017)

Submersible pressure transducers increasingly are being used for monitoring stage at surface-water gages. This is due to their ease of installation and maintenance, relatively low cost, and minimal requirements for shelter size, factors which provide more versatility in locating the instrumentation. For surface-water applications, a desirable transducer is accurate over a large range of stage and temperature; maintains its calibration; is easy to install and remove for repair; and is not prone to failure induced by water leakage or voltage surges (Freeman, et al., 2004).

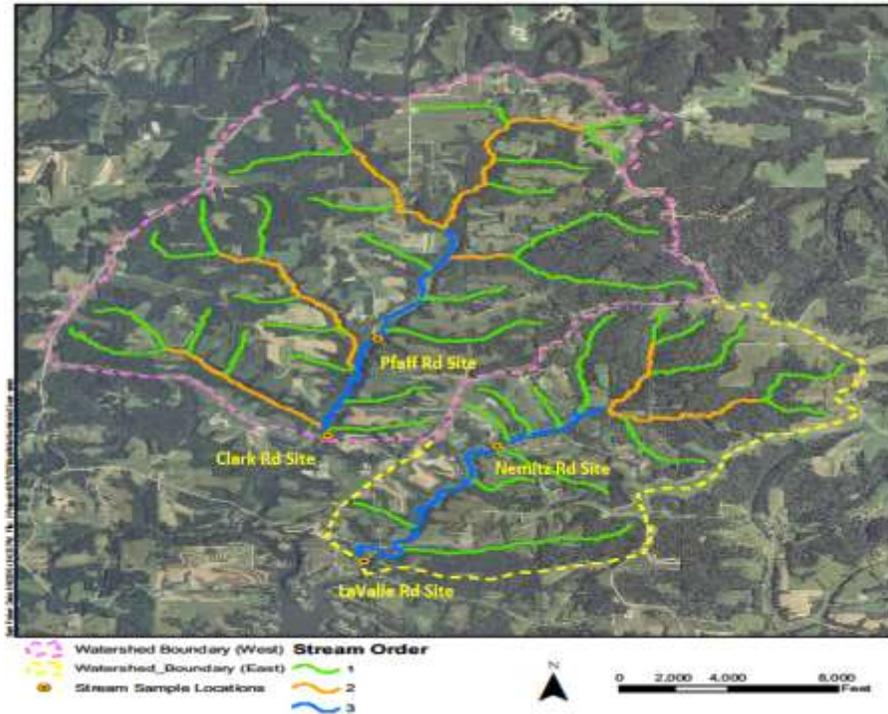
Figure 12 – Level 1-3 stream order tributaries to Lake Redstone (Koenig, 2014)

Several smaller, level one or two stream order tributaries have had TP and TSS data collected from them since at least 2014 by Sauk County and the LRPD (Figure 15). It is recommended that pressure transducers be installed on up to 6 level one or two streams based on previous TP and TSS data collected by Sauk County and the LRPD (Lucht, Pekala, Daus, Wafle, Pfaff, and Nemitz Roads).

Table 9 reflects TP and TSS data for the sites in Figure 12. TP averages ≥ 0.075 mg/L in streams is considered past the threshold for an impaired water (Wisconsin Department of Natural Resources, 2016 (Draft Version)). Table 10 reflects ortho data for the sites in Figure 12.

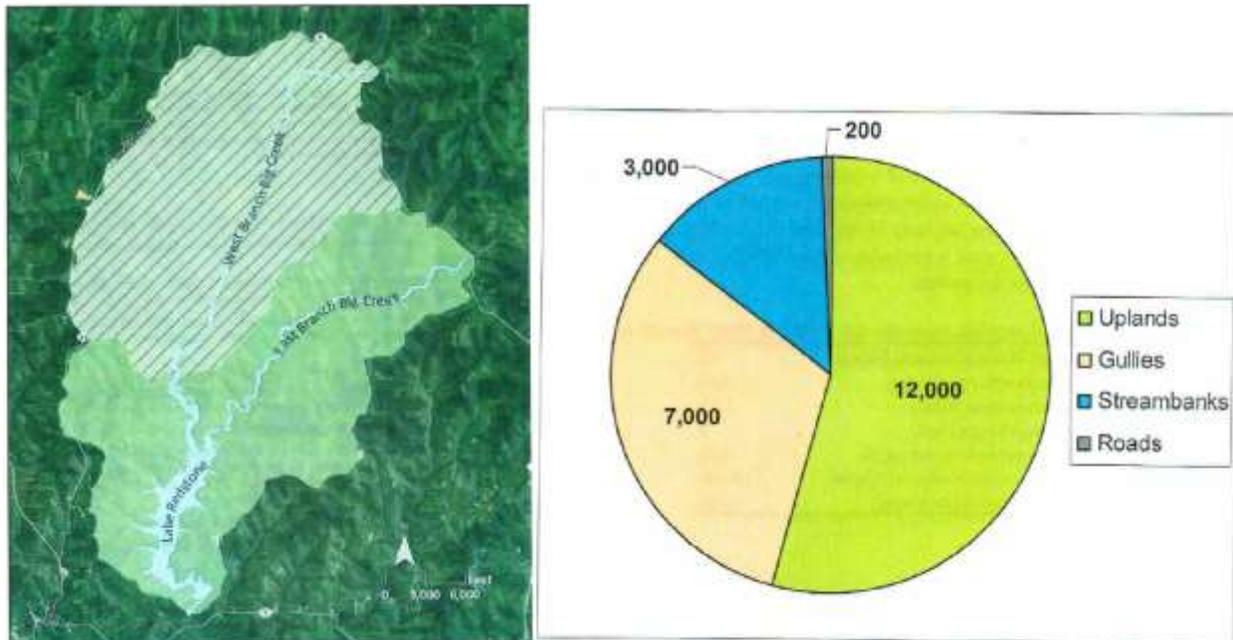
Figure 13 – West Branch of Big Creek portion of the Lake Redstone Watershed (left); estimated annual soil loss (right) (Montgomery Associates Resource Solutions, LLC, 2011)

In 2011 the LRPD commissioned a study by Montgomery Associates: Resource Solutions and General Engineering Company to evaluate the major sediment sources in the West Branch of Big Creek watershed (Figure 10) and to identify feasible sediment management measures (Montgomery Associates Resource Solutions, LLC, 2011). The study made use of previous studies, the knowledge of local residents and officials, and new field observations and analyses to come up with potential sediment management alternatives based on estimated annual soil loss from the West Branch portion of the watershed.

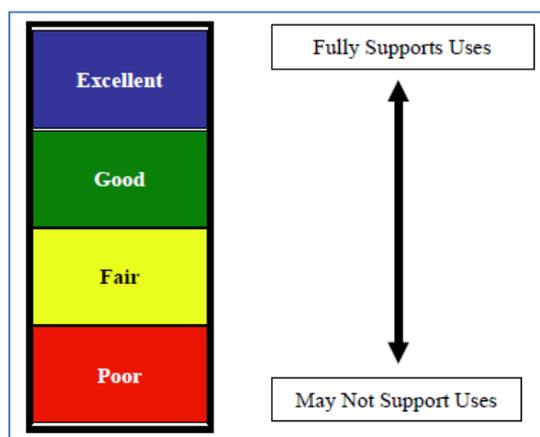
Figure 14 - General water condition continuum (Wisconsin Department of Natural Resources, 2016 (Draft Version))

The WDNR uses four levels of condition to represent waters’ placement in the overall water quality continuum (Figure 11). Waters assigned the condition category of excellent are considered to be attaining applicable WQS and fully supporting their assessed designated uses. Waters assigned the condition category of good or fair are also considered to be attaining applicable WQS and supporting their assessed designated uses. Waters assigned the poor condition category may not be attaining WQS or assessed designated use(s) (Wisconsin Department of Natural Resources, 2016 (Draft Version)).

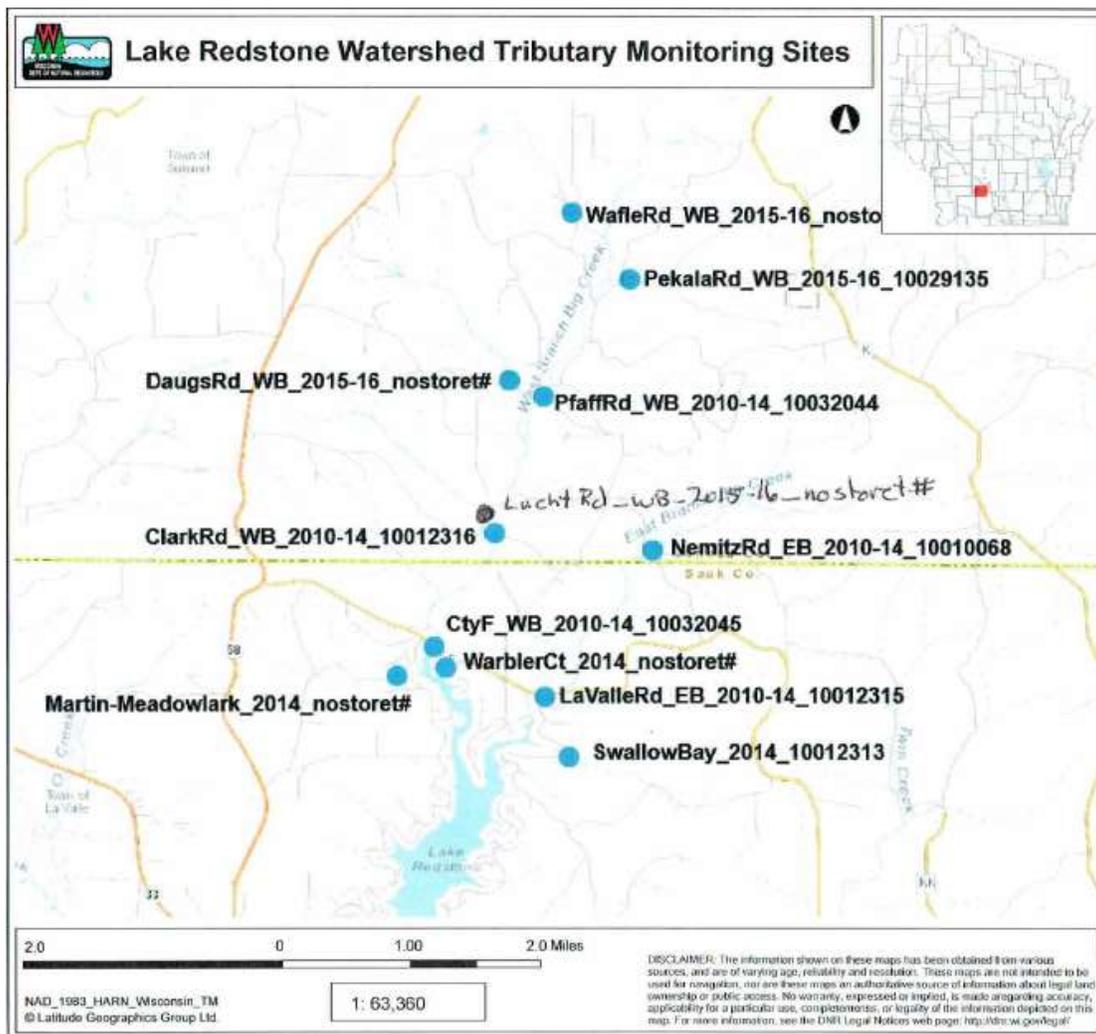
Figure 15 – Lake Redstone Watershed Tributary Monitoring Sites for Water Quality

Lake Redstone is an impound on Big Creek. There are two main branches of Big Creek that drain more than 19,000 acres to the lake. The West Branch of Big Creek drains approximately half of the entire watershed and the East Branch and immediate shoreland around the lake drains the rest. Water quality data including total phosphorus (TP), orthophosphates (ortho), total suspended solids (TSS), dissolved oxygen (DO), temperature, and flow/volume has been collected, with major years for data collecting in 2006-07, and 2010-2014. Figure 12 shows all the sites where water quality data has been collected. There are several other sites where biotic indices (macroinvertebrates) have been measured.

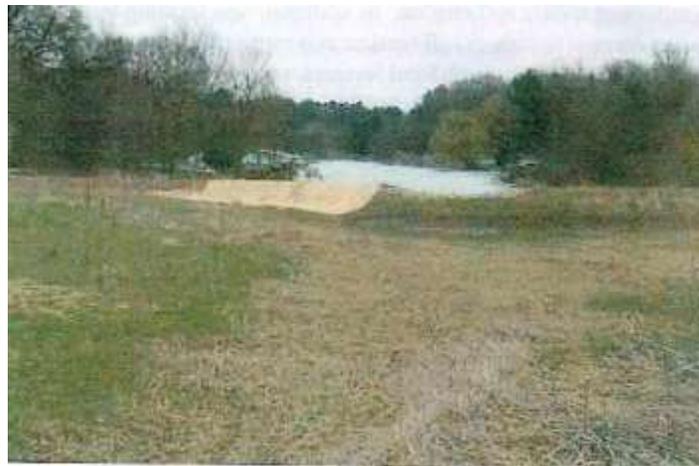
Figure 16- Sediment Trap at Mourning Dove Bay (Montgomery Associates Resource Solutions, LLC, 2011)

In the past, sediment ponds/traps have been installed at the head of several washes into Lake Redstone. The 2011 Sediment Management Study recommended installing sediment traps at high priority sites across the entire watershed however, with an estimated 800 gullies in the West Branch watershed alone, literally hundreds could be installed. Recent conversations between the LRPD and the WDNR have suggested that cleaning out previously installed traps could be considered an important first step, followed, perhaps by a feasibility study to look at just the heads of the multiple bays on Lake Redstone to determine whether additional sediment traps similar to the one installed at the head of Mourning Dove Bay (Figure 16) would be effective sediment management tools.

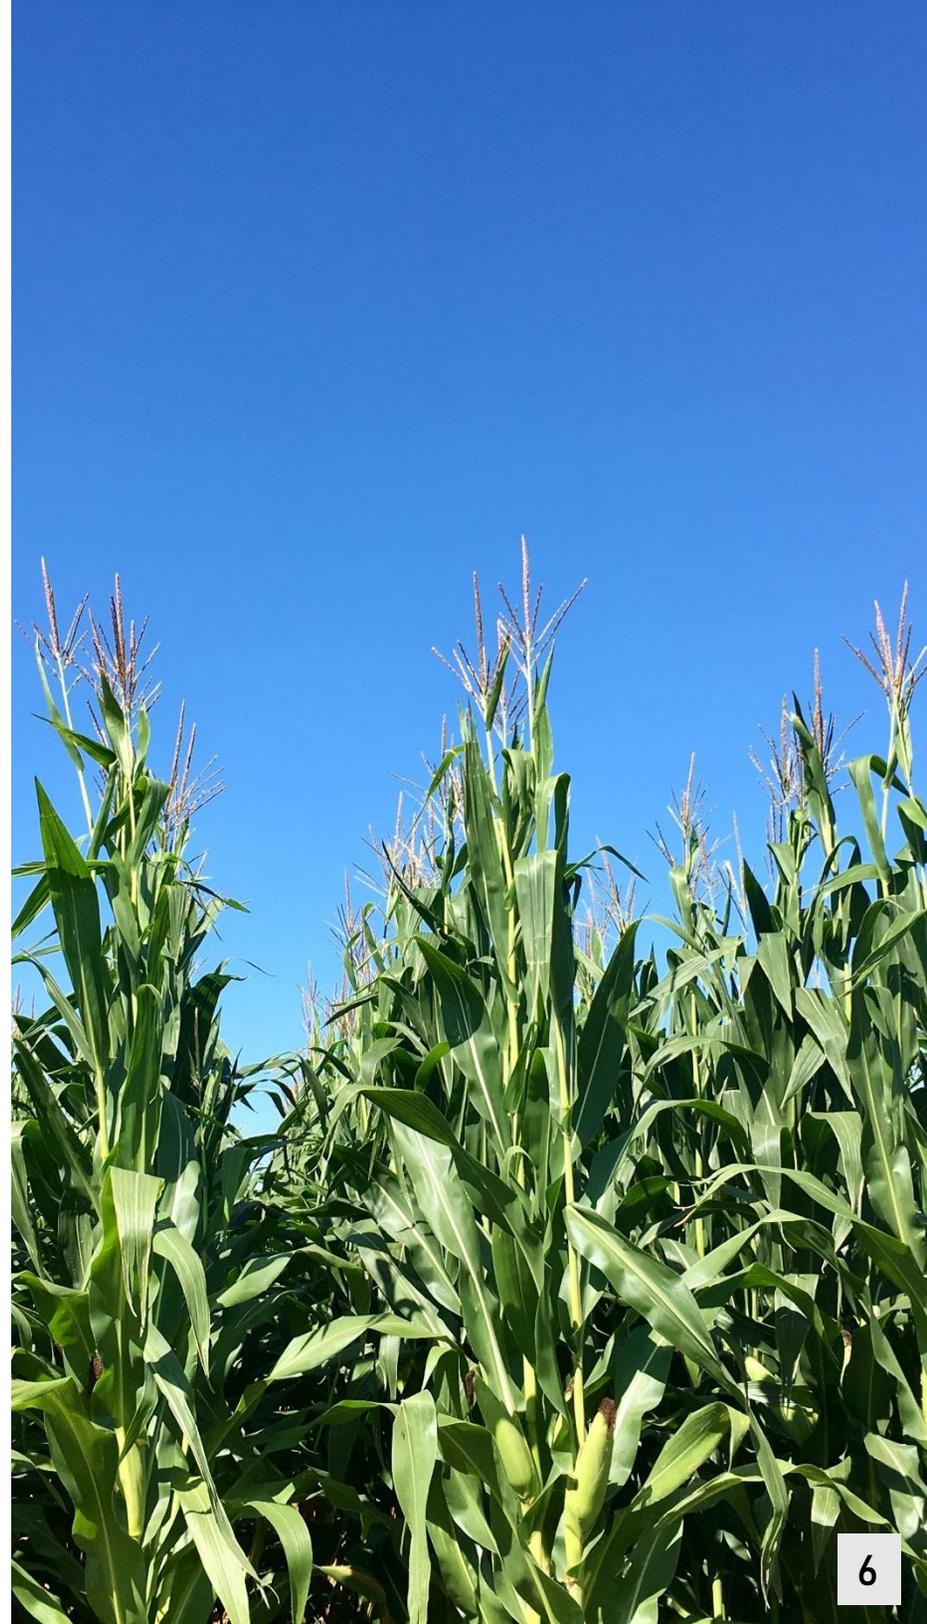
Less variability in soil erosion across fields with different slopes when using conservation practices

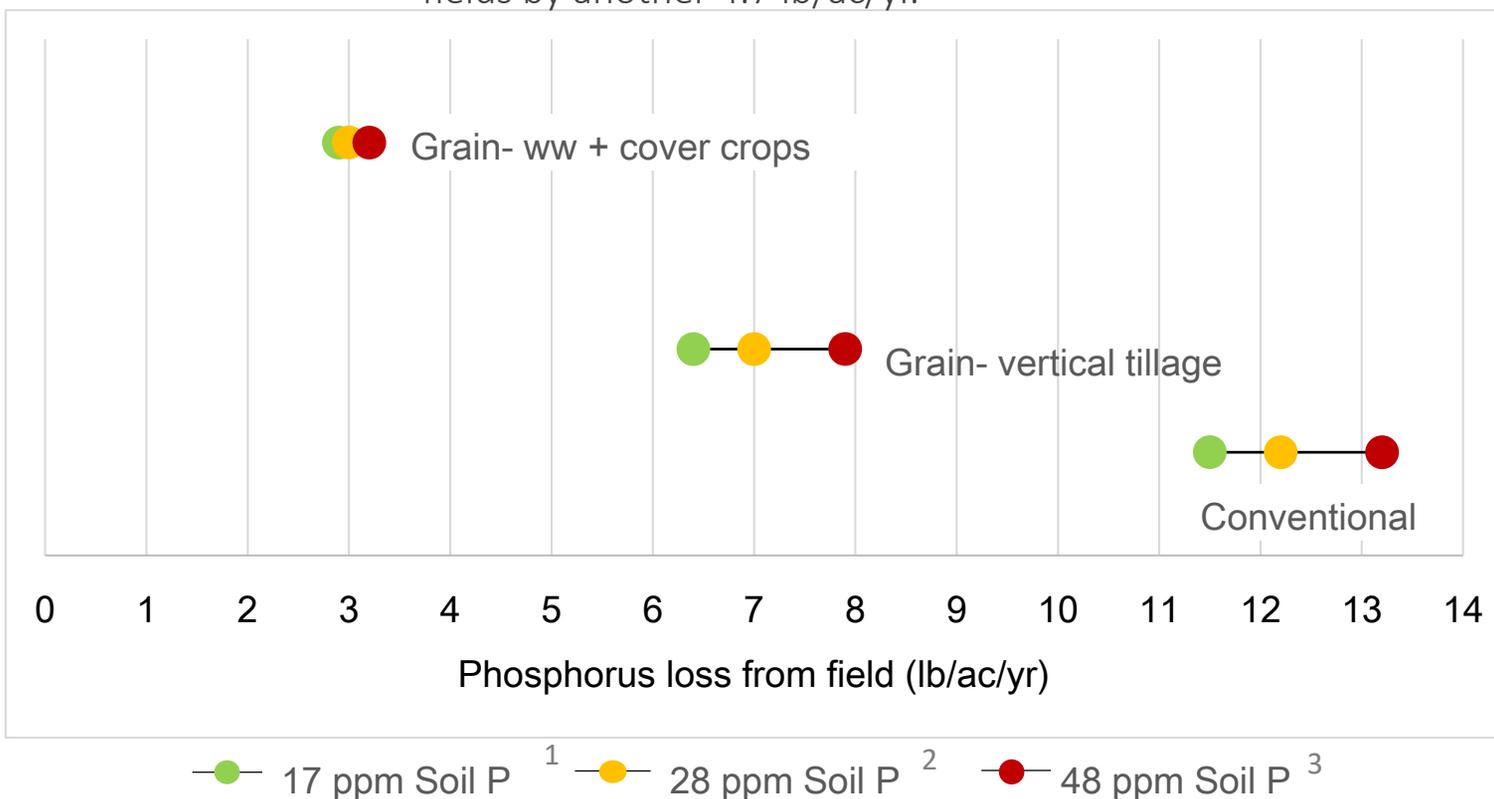
At the High P level, transitioning from Vertical Till to planting green into living covers can decrease phosphorus loss from fields by another 4.7 lb/ac/yr.

—●— 17 ppm Soil P ¹ —●— 28 ppm Soil P ² —●— 48 ppm Soil P ³

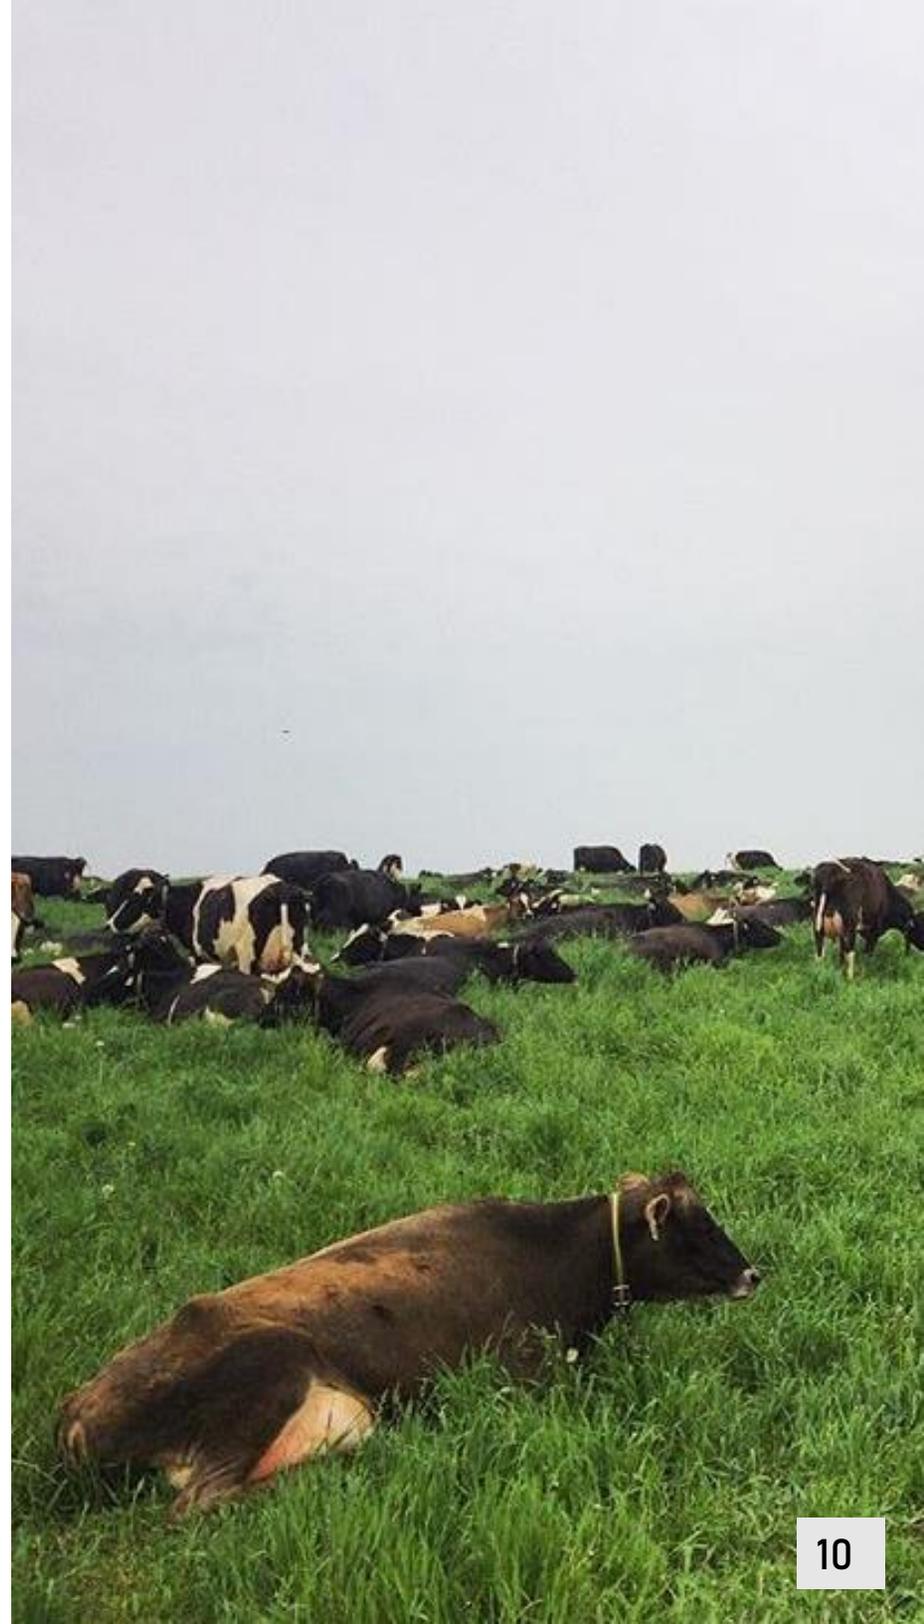
7.5
t/ac/yr

Soil erosion can be reduced by 7.5 t/ac/yr on certain soils in this watershed area with the use of cover crops after corn silage and introducing no-till into dairy systems

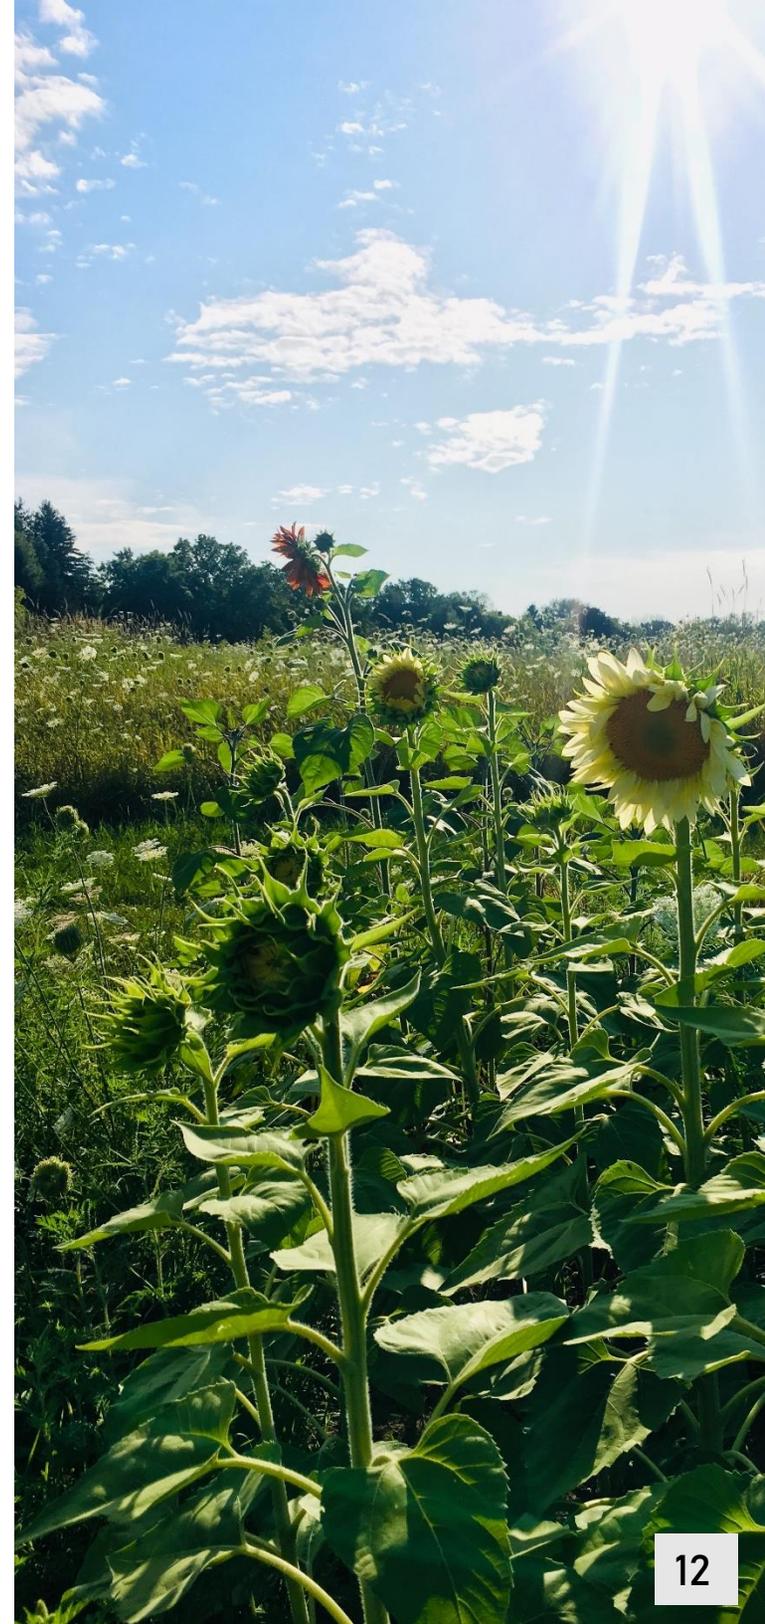
Decreasing tillage in dairy systems can lower phosphorus loss from fields.

Conservation practices can not only lower risk of P losses from the field, but also reduce the *variability* in phosphorus losses across fields with different soil phosphorus concentrations.

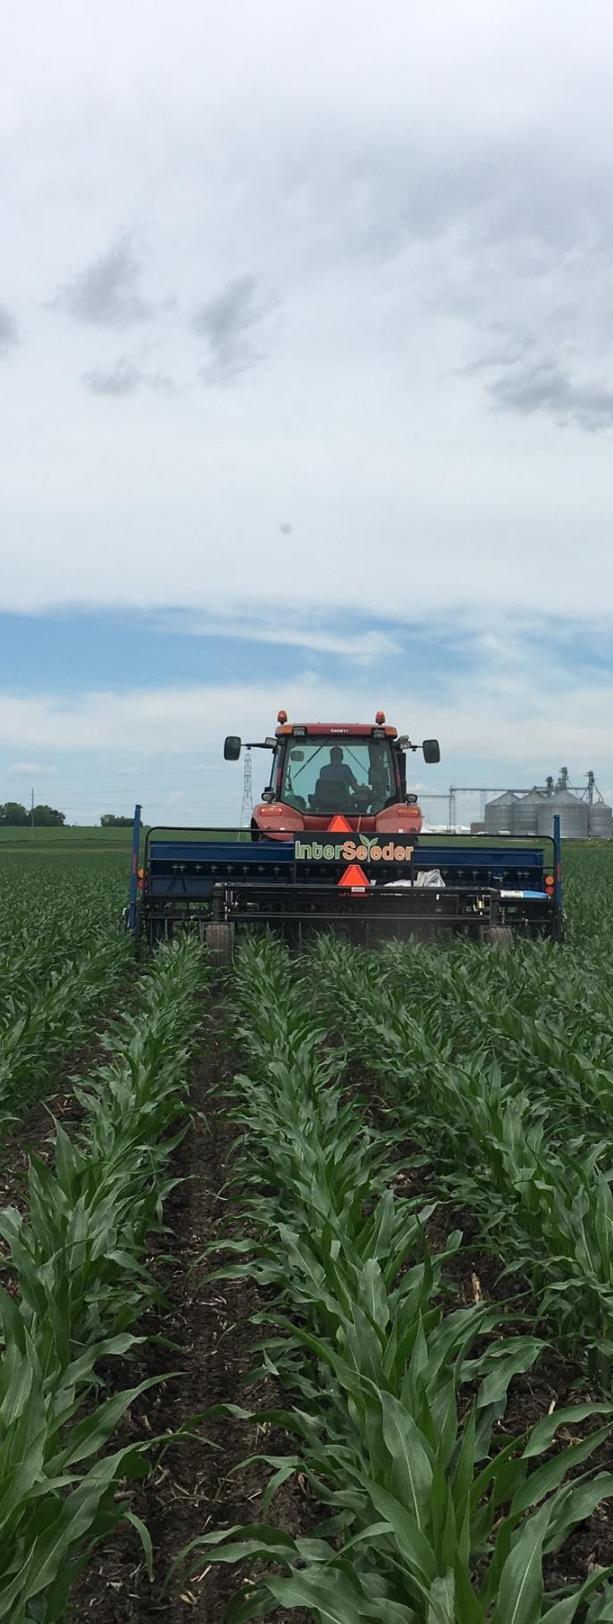
A higher Soil Conditioning Index means farming practices are encouraging **the building of soil organic matter**

The SCI predicts whether field soil is **gaining or losing carbon**. Values indicate direction of soil carbon building based off management practices like tillage. It does not reflect the actual quantity of carbon stored in the soil and a **value near zero doesn't necessarily indicate good management** if soil carbon levels have already degraded and they are being maintained at a low level.

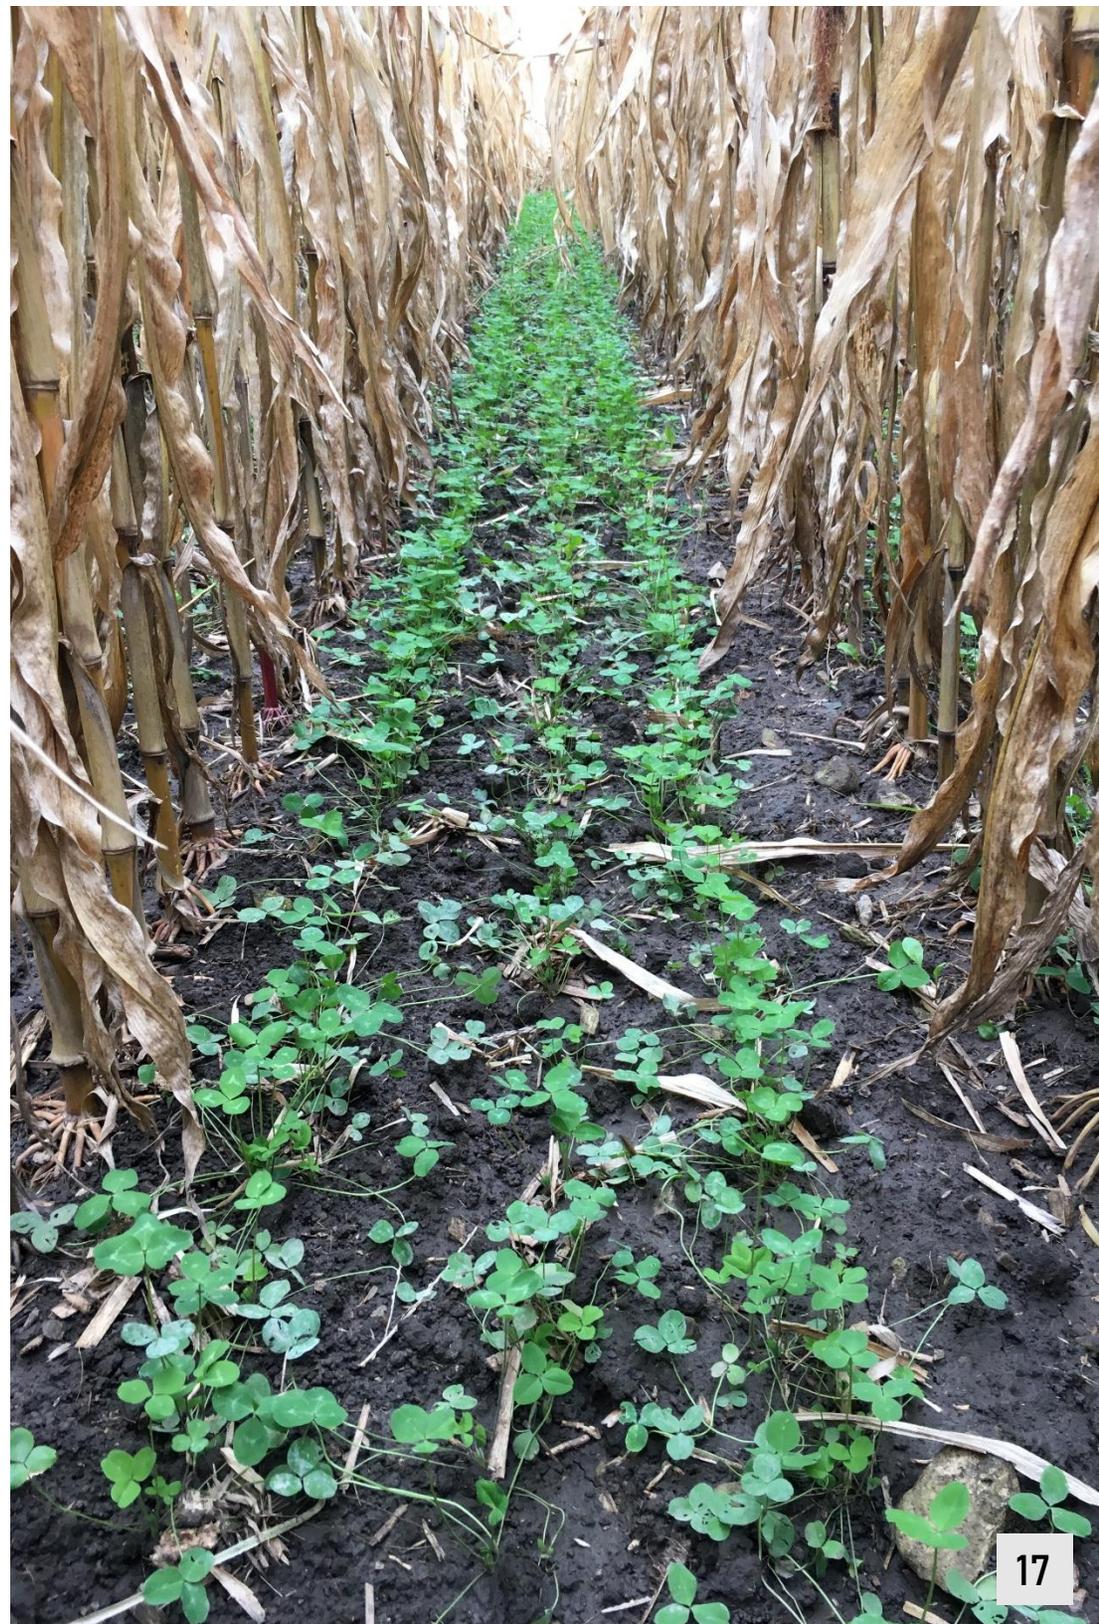
3,000 acres of cropland managed under a **grain system** could experience the following reductions* when switching from a **corn-bean system with chisel plowing** to:

**Vertical
Tillage**
