LAKE REDSTONE

2022-32 9-KEY ELEMENT WATERSHED AND LAKE MANAGEMENT PLAN

January 27, 2022

Developed by: Dave Blumer, Megan Mader, and Heather Wood
Lake Education and Planning Services, LLC
Cameron, WI 54822

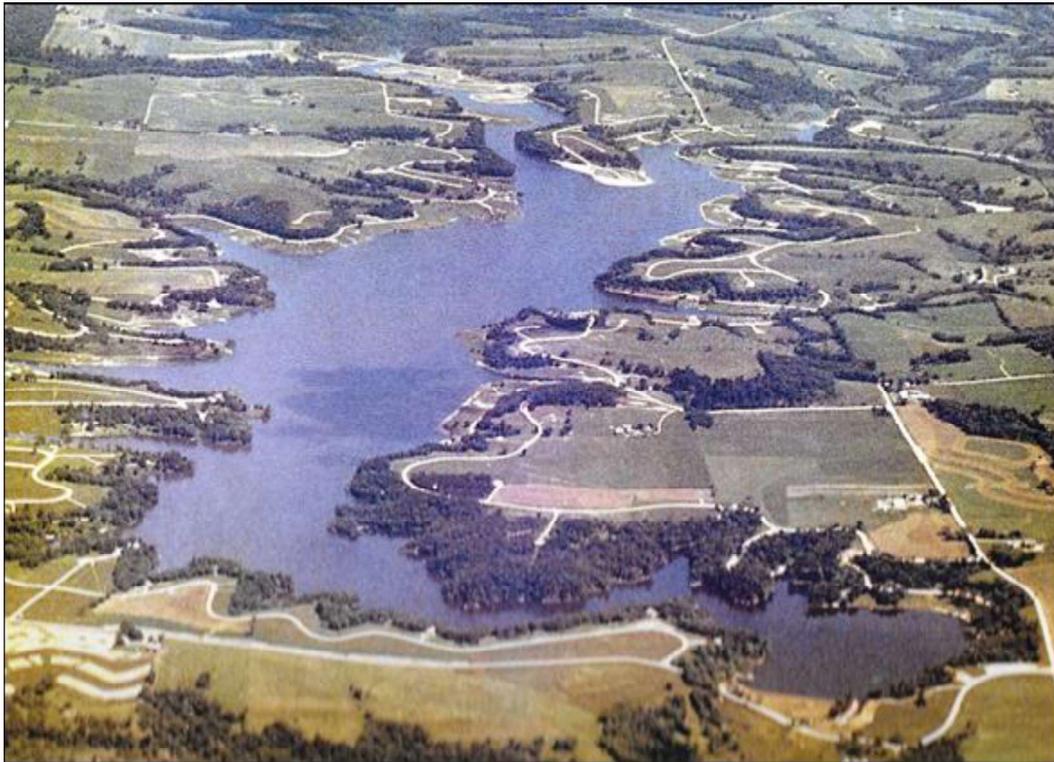
Figure 1: Lake Redstone shortly after filling. The two branches of Big Creek that flow into the lake are at the top of the picture. The dam is located at the lower right of the picture.

Lake Redstone was created in the mid 1960's when a 38 foot high earthen dike was installed across Big Creek in northwestern Sauk County with the intent of creating >1500 lots for development. It has 17½ miles of shoreline and it is 4½ miles long. Lake Redstone is located in the Crossman Creek and Little Baraboo River watershed which lies in northwestern Sauk County, southern Juneau County, northeastern Richland County, and the southeast corner of Vernon County. It is part of the Driftless, or unglaciated, region of Wisconsin. This region is geologically unique with land areas that were by-passed by the last glaciers leaving steep terrain susceptible to flash runoff events and erosion that can increase the amount of sediment and nutrients lost from agricultural land and carried be into streams, rivers, and lakes.

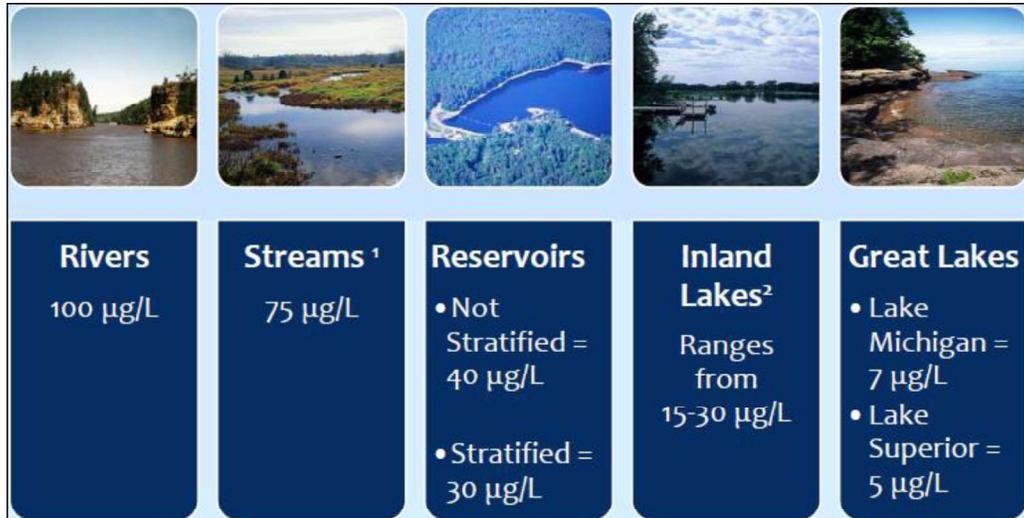
Figure 4: Wisconsin numeric water quality standards for phosphorus (WI-DNR, 2019)

The Wisconsin acceptable standard for summer TP in the REC category for stratified reservoirs like Lake Redstone is a geometric mean concentration $\leq 30\text{-}\mu\text{g/L}$ (Figure 4). If the summer mean concentration of TP exceeds this level, the water is considered impaired. The Wisconsin assessment protocol for Chl-*a* is based on the number of days in a sampling season (July 15-September 15) that have moderate algal levels based on Chl-*a* concentrations that exceeds $20\text{-}\mu\text{g/L}$. Once that level has been exceeded, the amount of algae in the surface water it represents discourages people from swimming (Figure 5). If the concentration of Chl-*a* exceeds $20\text{-}\mu\text{g/L}$ on more than 5% of the expected lake use days, then the water is considered impaired.

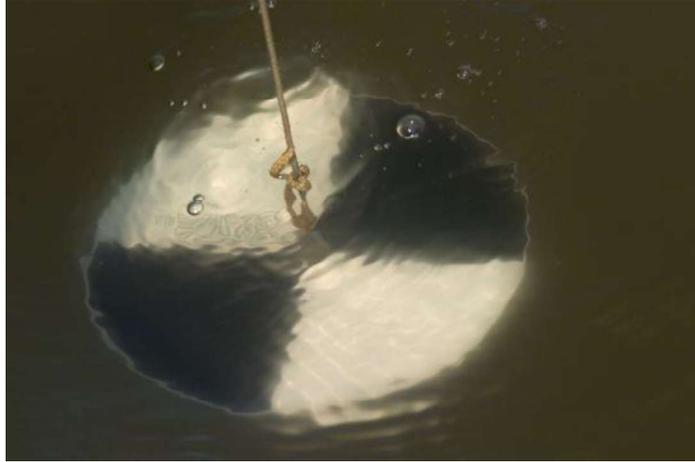
Figure 8: Secchi disk

Water clarity is a measurement of how deep sunlight can penetrate into the waters of a lake. It can be measured in a number of ways, the most common being an 8” disk divided into four sections, two black and two white, lowered into the lake water from the surface by a rope marked in measurable increments (Figure 8). The water clarity reading is the point at which the “Secchi” disk when lowered into the water can no longer be seen from the surface of the lake. Water color (like dark water stained by tannins from nearby bogs and wetlands), particles suspended in the water column (like sediment or algae), and weather conditions (clouds, wind, or sunlight) can impact how far a Secchi disk can be seen down in the water. Some lakes have Secchi disk readings of water clarity of just a few inches, while other lakes have conditions that allow the Secchi disk to be seen for dozens of feet before it disappears from view.

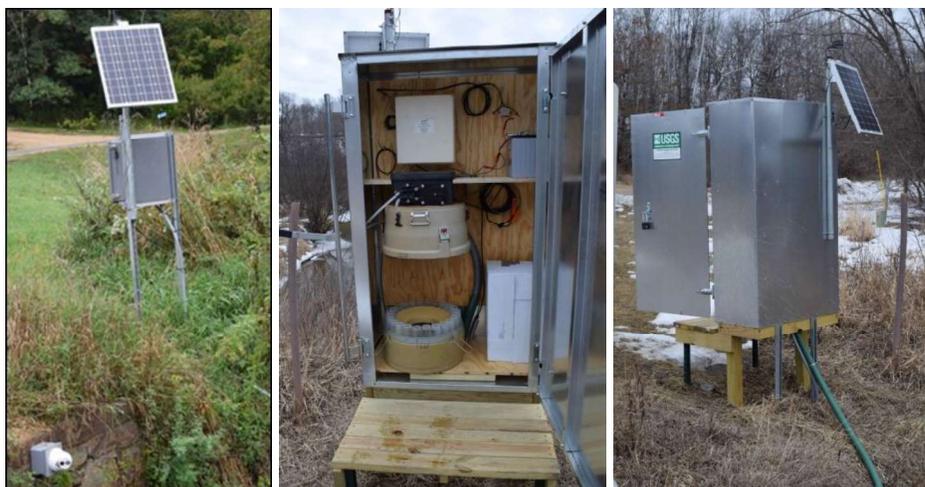
Figure 33: Camera installation for “camera image stage-interpretation” (left) (K. Keegstra, 2019); Typical USGS recording streamflow-gaging station with automatic water sampler for load determinations (middle & right) (K. Keegstra, 2021)

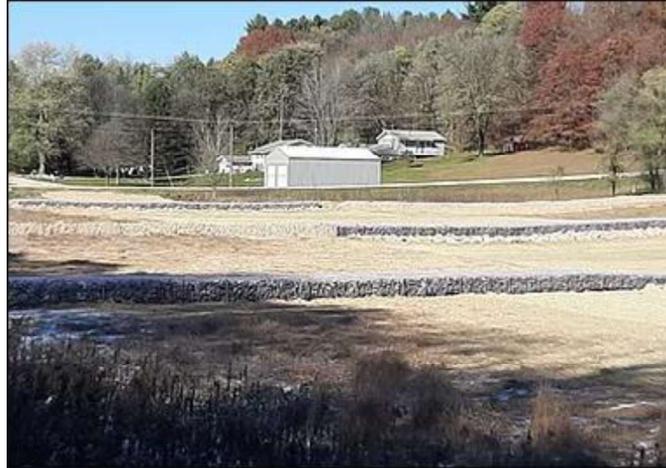
Figure 38: Stone-filled gabion baskets placed at the head of Mourning Dove Bay (LRPD Website)

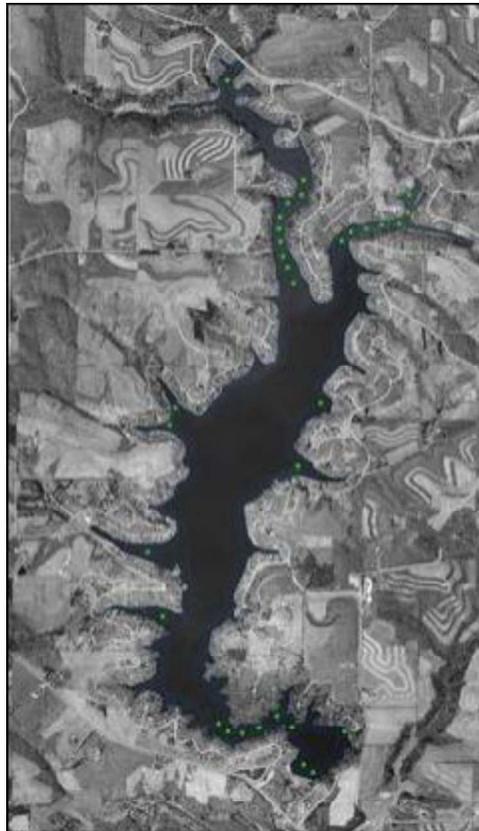
Figure 39: Approximate location of buoys designating “no-wake” areas on Lake Redstone (Town of LaValle)

buoys essentially wherever the distance from shore to shore is 400-ft or less (Figure 39). In addition, the Town of LaValle has an ordinance (Section 11.01.05 Controlled Areas), that establishes an Emergency Slow No-Wake designation for all of Lake Redstone during high water conditions. Aquatic invasive species education, planning, and prevention activities/BMPs including Clean Boats, Clean Waters and AIS monitoring are implemented on a regular basis by the LRPD and supported by the Town of LaValle and LRPOA.

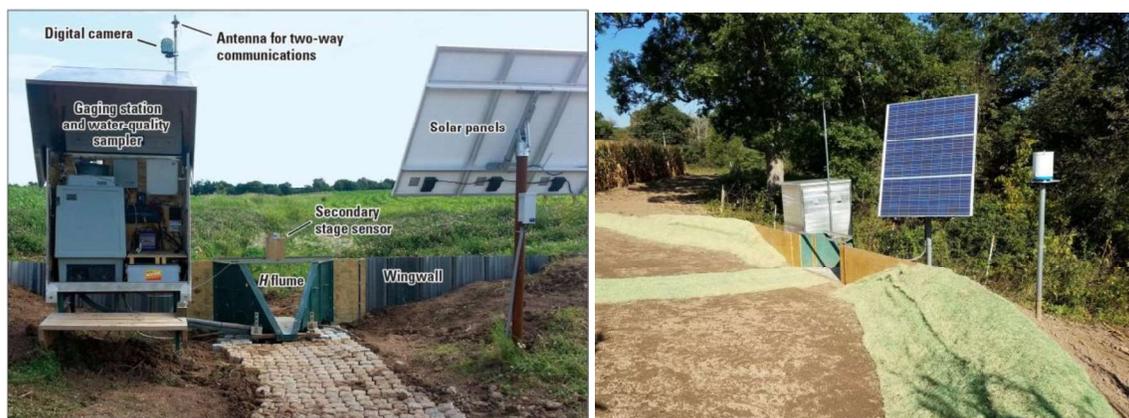
Figure 40: Example edge-of-field surface water monitoring station/system (left); actual Lake Redstone watershed edge-of-field monitoring station

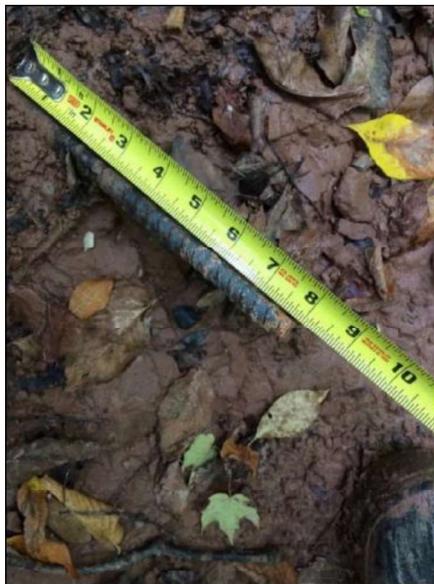
Figure 43: Erosion pin inserted into a streambank showing 8” of soil eroded after inspection in Kankapot Creek, Calumet County, Wisconsin.
