2022

Aquatic Plant Survey Report

Lake Redstone Bays

Sauk County, Wisconsin

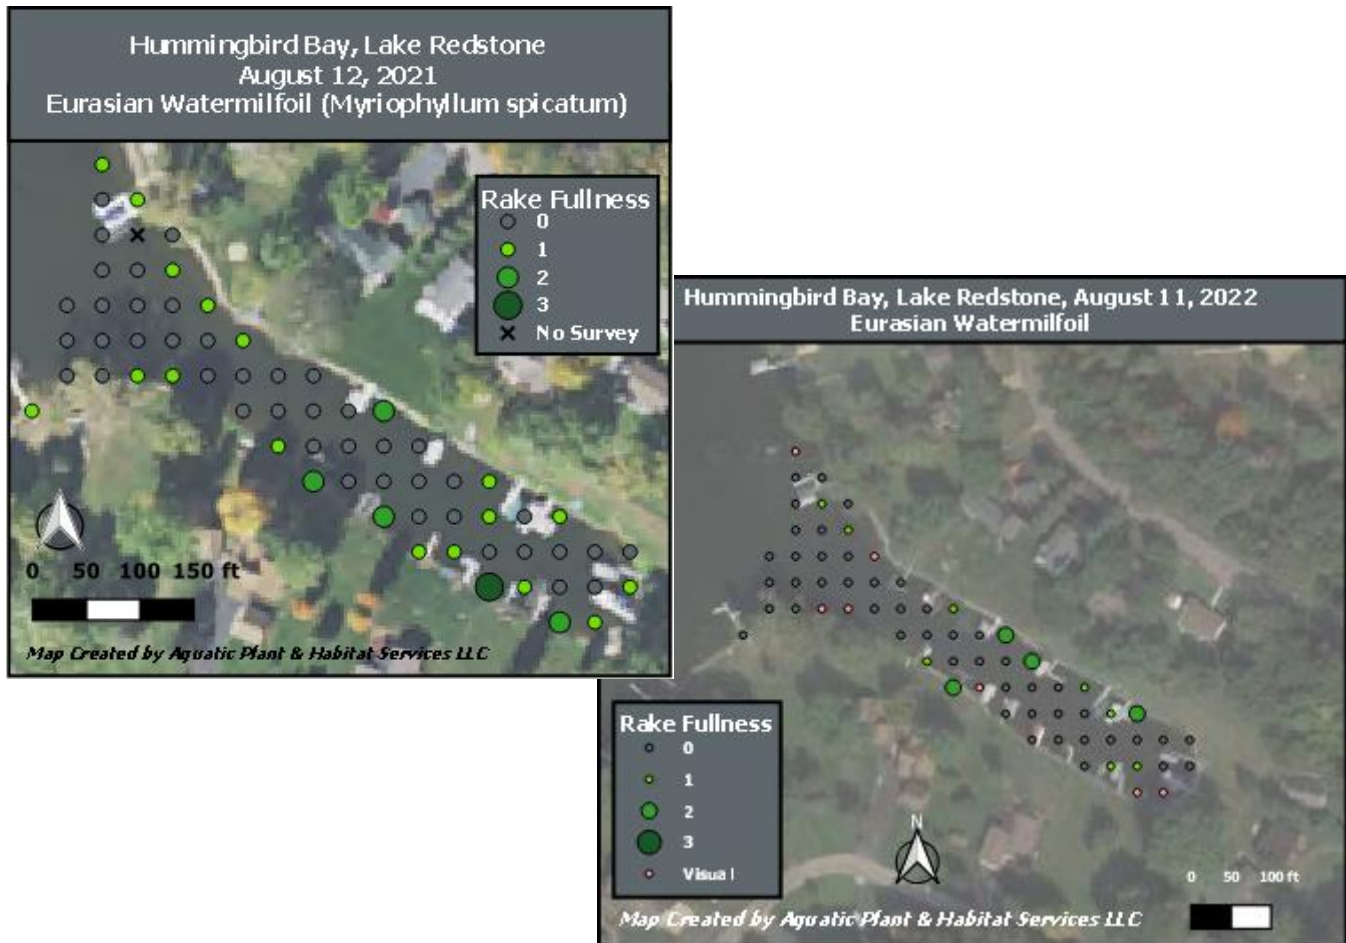
Figure 8 – Hummingbird Bay Eurasian Watermilfoil Maps 2021-2022

- EWM was the most common species at 12 survey points (another 7 visual).
- Herbicide treatment was conducted in Hummingbird Bay in spring 2017.
- A chi-squared test of EWM revealed no significant change in EWM between 2016 and 2022 nor between 2021 and 2022.

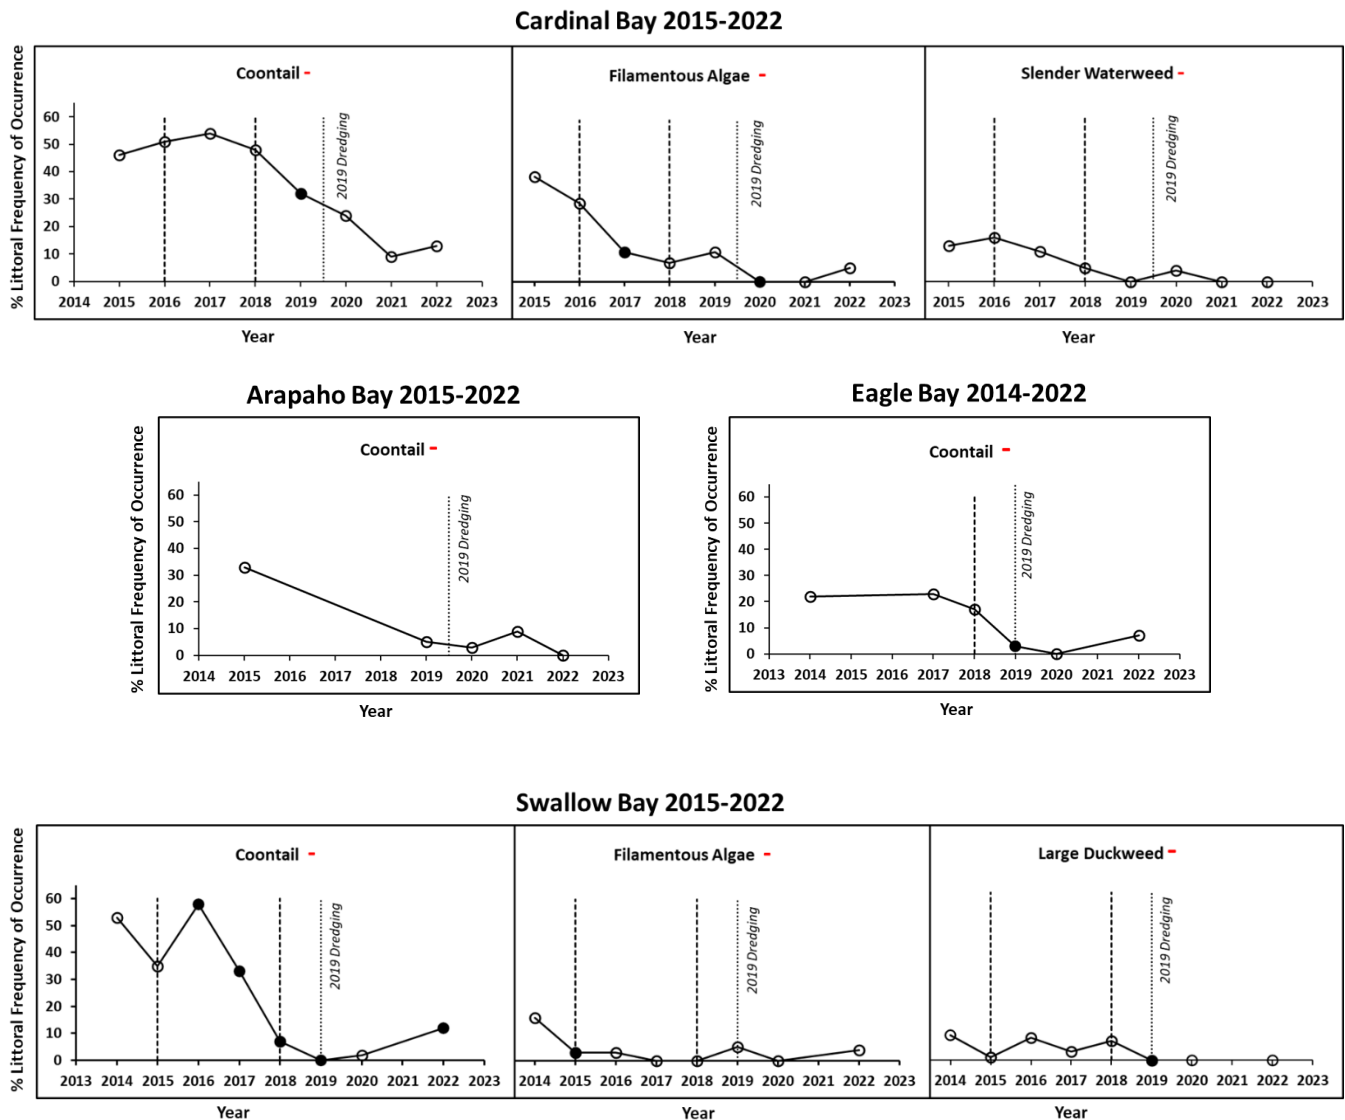
Percent littoral frequency (# sites plants found at points shallower than maximum rooting depth divided by the number of site shallower than max depth of plants) is on the y-axis and each year a plant survey was completed is on the x-axis. Only species with a statically significant change (using Chi-squared tests) for most recent year vs 2022 or the first year vs 2022 are displayed. The dashed vertical lines represent years when herbicide treatments were done with the exception of the dashed line in 2019 that represents dredging as labeled. Open circles represent **no** statistically significant change compared to previous year, solid circles represent a statistically significant change compared to previous year. Statistically significant changes between the first year of surveying and 2022 data are represented by + or - adjacent to plant names.
