## Aquatic Plant Survey Report Lake Redstone Bays

Sauk County, Wisconsin

Arapaho, Cardinal, Chickadee, Hummingbird,  
Mourning Dove, & Oriole

Project initiated by:  
Lake Redstone Protection District

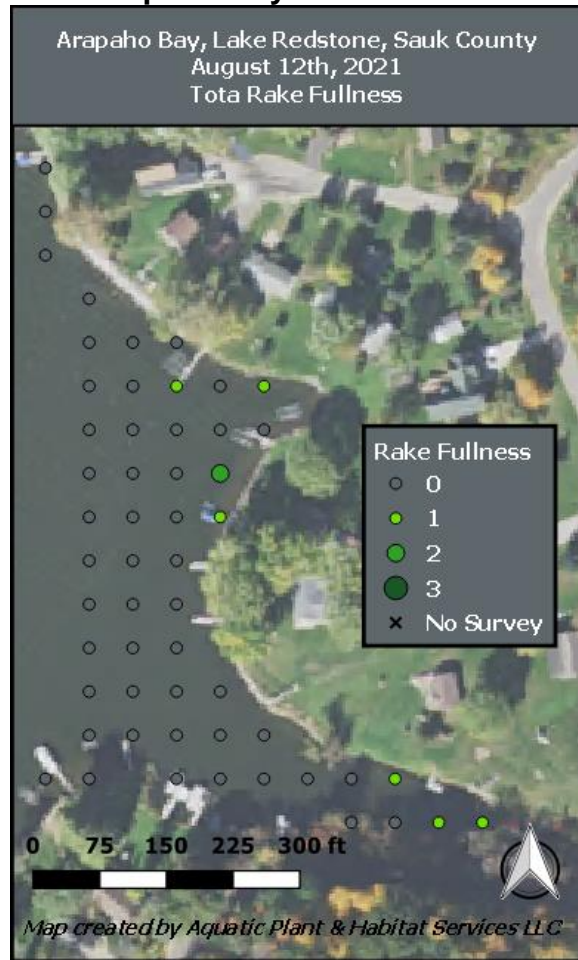
**Figure 5 – Arapaho Bay Total Rake Fullness Map**

This was the fourth survey of Arapaho Bay, the first being 2015 using the name “Tanager Bay.” A total of 55 points were sampled and the maximum rooting depth was only 4 feet compared to 6 feet in 2020 and 8 feet in 2019. It is worth noting in 2019 that the maximum rooting depth of 8 feet occurred with coontail found at one sample point with the next deepest rooting depth of 5 feet. Eleven sample points were  $\leq 4$  feet deep and only 7 of those sites had vegetation. A total of 5 species were found including EWM and one of which was visual only (maps in Appendix A). Similar to all previous surveys of the bay, Eurasian watermilfoil was the most common species found at 45% of littoral points in 2021, 31% in 2020, 24% in 2019, and 33% in 2015. Three native species were found at only 10% of littoral points each. Similar to previous years, the plant community is homogeneous. The Simpson Diversity Index was 0.56 on a scale from 0 to 1. The FQI only factors species raked at survey points and does not include invasive species. Therefore, 3 species were counted yielding a floristic quality of 7.5 and an average C value of 4.3 (Table 5). Chi-squared tests revealed no statistically significant (SS) changes in the aquatic plant community when comparing 2020 to 2021 but there was a significant decrease in one native species (coontail) when comparing 2015 to 2021 (Appendix G).

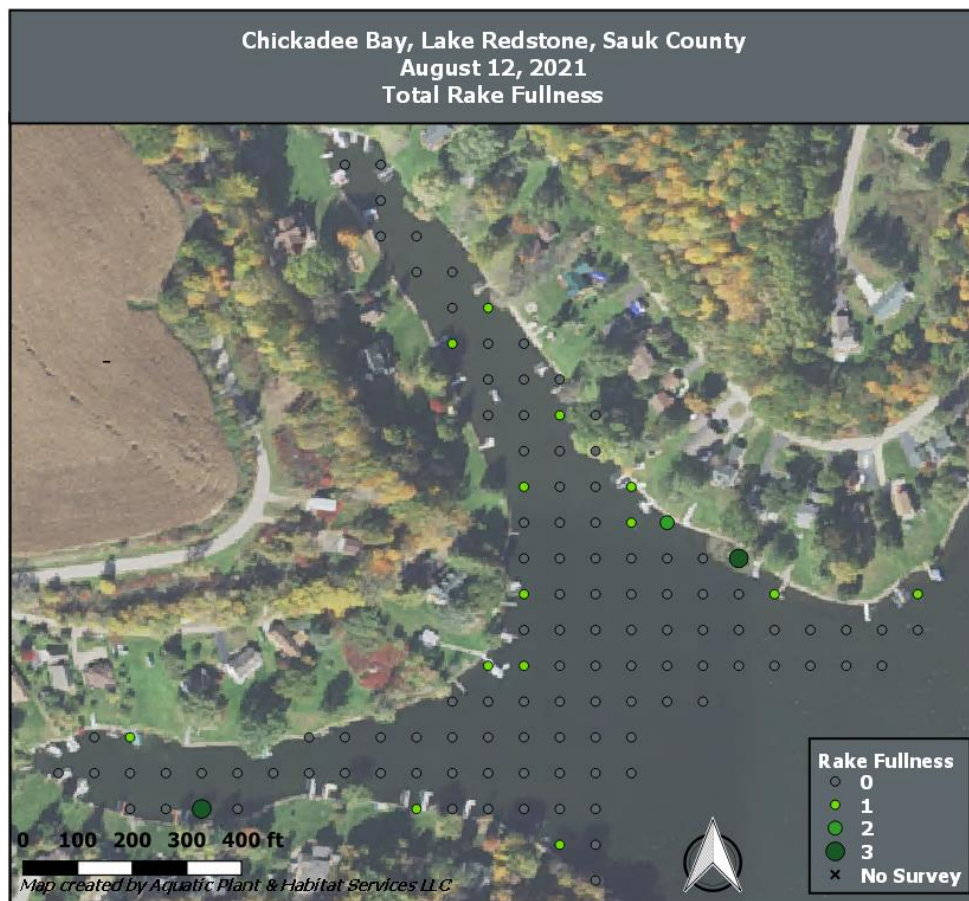
**Figure 7 – Chickadee Bay Total Rake Fullness Map**

This was the fourth survey of Chickadee Bay, the first of which occurred in 2015. The south arm of Chickadee Bay was also surveyed 2016 through 2018. Only results from the 2015, 2019, 2020, and 2021 surveys are listed in this report. There were 119 points surveyed in Chickadee Bay, 77 of which were the same depth or shallower than the maximum rooting depth of 6.5 feet. There were 17 sites with vegetation (Table 4). A total of 6 species were found on the rake samples including EWM (maps in Appendix C). Similar to 2019 and 2020, EWM and coontail were the most common species found at 76% and 41% of littoral survey points respectively. Together they accounted for 80% of the total relative frequency, indicating a highly homogeneous plant community in the bay (Table 3). The Simpson Diversity Index was 0.64 on a scale of 0 to 1. The FQI only factors species raked at survey points and does not include visuals or aquatic invasive species. Therefore, 5 species were included in the calculation, resulting in a floristic quality of 11.6 and average C value of 5.2 (Table 5). Chi-squared tests revealed a statistically significant (SS) decrease in EWM in 2021 when compared to 2020, and no SS changes in 2021 when compared to 2015 (Appendix G).

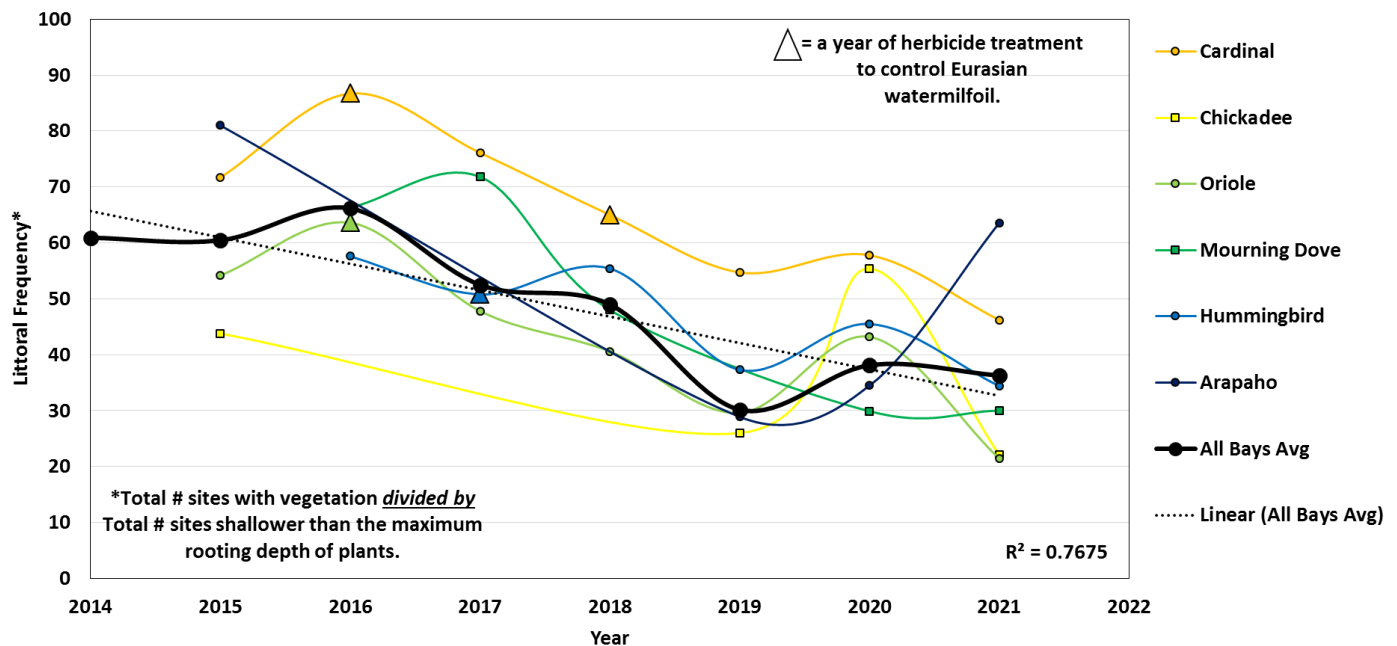
**Figure 17 – Littoral Plant Frequency Graph**

The graph in Figure 17 charts a function of the total number of sites where plants (native & non-native) *do* occur vs. the total number of sites where plants *could* occur, AKA littoral frequency (Table 4), thereby factoring in water clarity because it only includes points that are equal to or shallower than the maximum depth of aquatic plants. In theory, if water clarity declines so do the number of points shallower than the maximum depth of plants. This graph shows that average littoral frequency was lowest in 2021 for all bays<sup>5</sup> except Arapaho Bay. A linear trendline<sup>6</sup> of the average littoral frequency among all bays<sup>7</sup> surveyed each year suggests the littoral frequency of aquatic plants (combined native and non-native) has been on a downward trend from 2014 through 2021 with an R<sup>2</sup> value of 0.77.<sup>8</sup> This trend could be due to environmental factors such as the historic flooding in the area in 2018 that also likely impacted aquatic plant growth the following year (2019). The trend does not appear to be consistent among only bays treated with herbicide. In other words, herbicide treatment in a given year does not appear to be a main factor in driving down littoral frequency of all species, although it can't be ruled out as a contributing factor.

<sup>5</sup> Mourning Dove Bay was lowest in 2020 at 29.9% littoral frequency and nearly identical in 2021 at 30%.

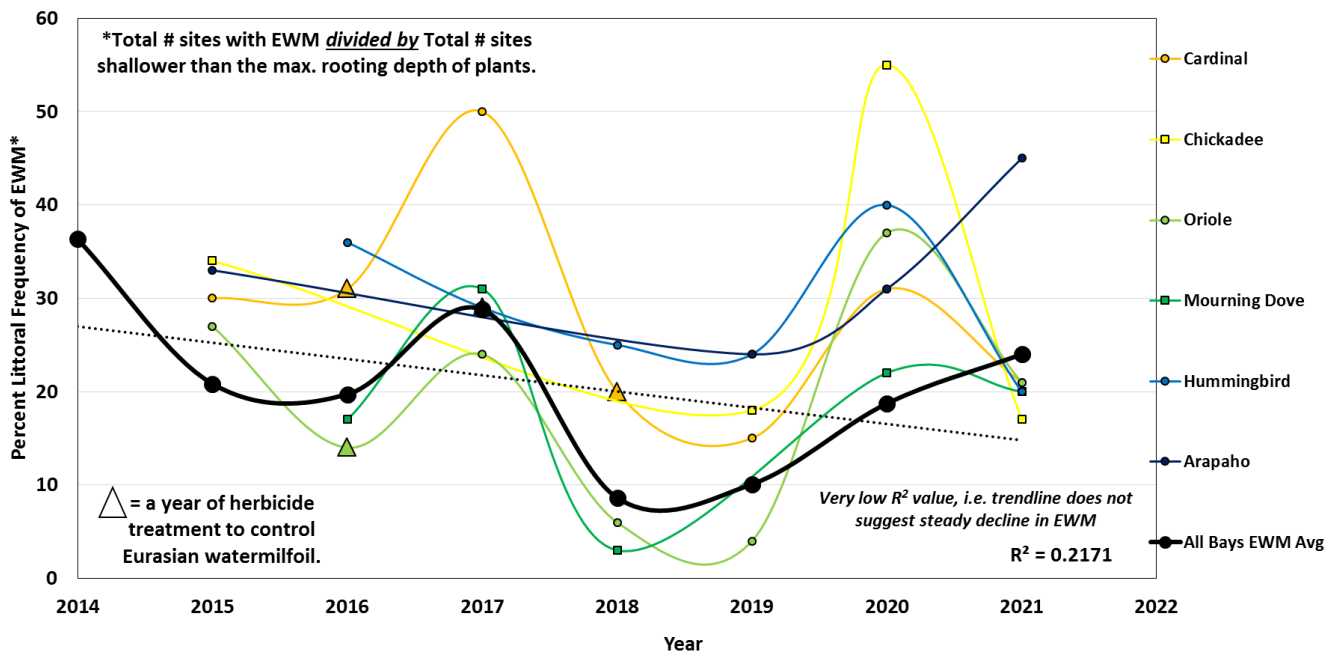
**Figure 18 – Eurasian Watermilfoil Littoral Frequency Graph**

Figure 18 illustrates EWM littoral frequency in the six bays surveyed from 2015 through 2021. **In summary, all bays except Arapaho Bay had lower EWM occurrence in 2021 compared to 2020. The decrease in EWM was statistically significant in Chickadee and Hummingbird Bays.** This is in contrast to 2020 results when 13 bays had increased EWM occurrence after dredging occurred in 2019, which was unexpected because the act of dredging removes sediment and along with it come roots and seeds. However, EWM and non-native/invasive species in general thrive in disturbed environments and the dredging may have opened a niche for EWM to recolonize more quickly than native species. Furthermore, EWM samples from Lake Redstone were collected in 2021 for genetic testing to rule out the presence of hybrid watermilfoil, which is the genetic cross between Eurasian watermilfoil and native northern watermilfoil (*Myriophyllum sibiricum*). Although Lake Redstone does not have northern watermilfoil present, the introduction of the hybrid strain could occur through boat traffic. The most recent genetic testing of Lake Redstone EWM was done in 2013 with results concluding the milfoil was Eurasian and not hybrid. Results of the 2021 samples are expected in early 2022.
