# 2023

## Aquatic Plant Survey Report

### Lake Redstone Bays

Sauk County, Wisconsin

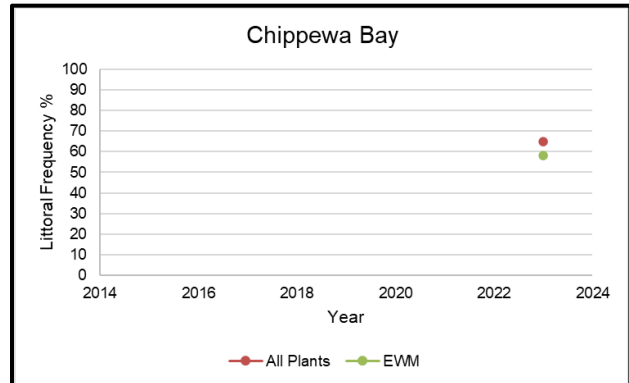
## Chippewa Bay 2023

- Max rooting depth = 6ft
- Total # sites shallower than 6ft = 31
- Total # sites with vegetation = 20
- 20/31 = 65% Littoral frequency all plants
- Most common plant was EWM at 18 sites
- No Chi-square test was done because this was the first year surveying Chippewa Bay
- Chippewa Bay is NOT designated as a critical habitat area

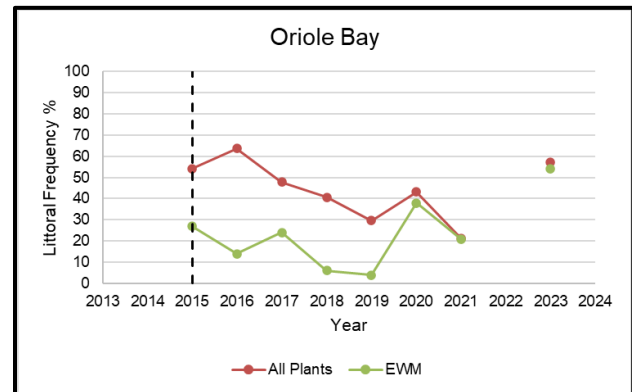
## Oriole Bay 2023

- Max rooting depth = 5.5ft
- Total # sites shallower than 5.5ft = 28
- Total # sites with vegetation = 16
- $16/28 = 57\%$  Littoral frequency all plants
- Most common plant was EWM at 15 sites
- Chi-squared tests revealed a statistically significant increase in small pondweed between 2021 and 2023. There was a significant decrease in coontail and slender waterweed in 2023 when compared to 2015 (see graphs in Appendix F).
- Oriole Bay is designated as a critical habitat area.
